Englishman River Claybank Stabilization Geomorphic Impact Assessment

Northwest Hydraulic Consultants Ltd.

October 4, 2023

Final Report, Rev. 1

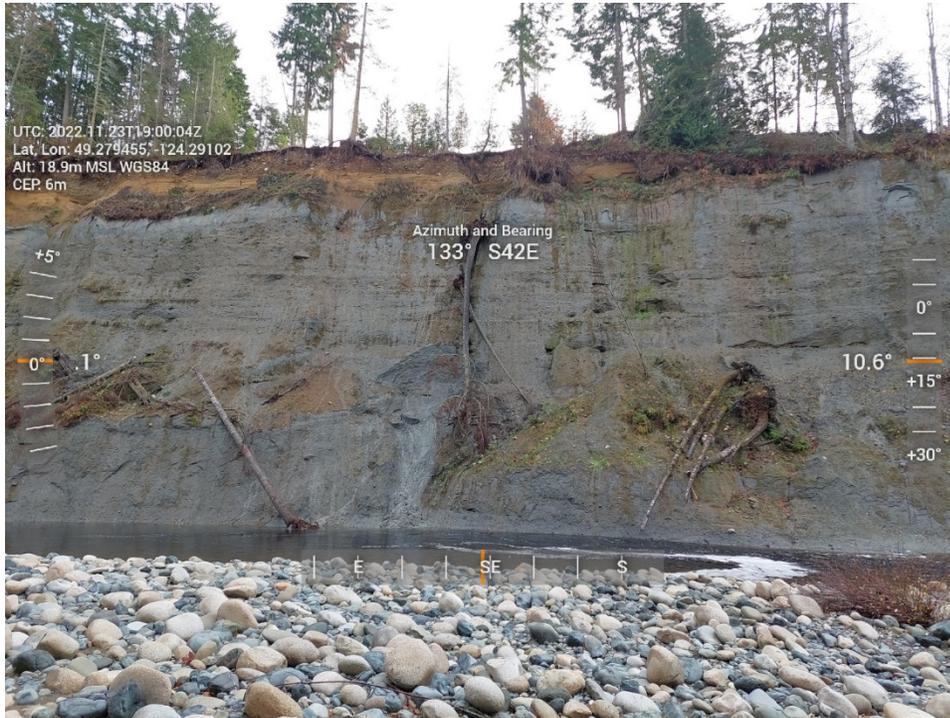
The upstream claybank (RK 8.6) is approximately 30 to 35 m high, extending about 100 m downstream before the river moves north and transitions into 5 m high alluvial banks. The claybank is composed of three distinct units. The top layer is approximately 2 to 3 m thick, composed of sand and gravel, below which is a 3 to 5 m thick layer of orange sandy material, mapped as a glaciofluvial delta deposit (Figure 2.3). The lower 25 m of the bank is composed of Vashon Drift till (Photo 3.1). Two samples of this unit were collected by BCCF in August 2022 and sent to Bureau Veritas lab for sieve analysis. The results of this analysis show that the till is composed of 19-22% clay, 29-30% silt, 49-52% sand, and < 2% gravel (Table 3.1). The high clay content makes this unit particularly cohesive, and compression from overriding ice during deposition has made the sediment particularly compact.

Photo 3.1 Photograph of the upstream eroding claybank (RK 8.6).

Field observations indicate the toe of the claybank at RK 8.6 is being eroded by the Englishman River. Exposed roots are visible along trees lining the top of the bank, and several trees have recently been undermined and fallen downslope (Photo 3.1). The lower bank appears to be contributing soil directly into the channel, perhaps by block failures when the river erodes the toe of the slope, as well as during freeze-thaw and other weathering events (Photo 3.2). Failed material and debris input to the channel is likely flushed downstream relatively quickly by the river. Jeremy Damborg (BCCF) noted that small-scale inputs from the claybank are mobilized during moderate flows and tend to be deposited in the downstream sections of channel, negatively impacting habitat quality (pers. comm. April 14, 2023, email).

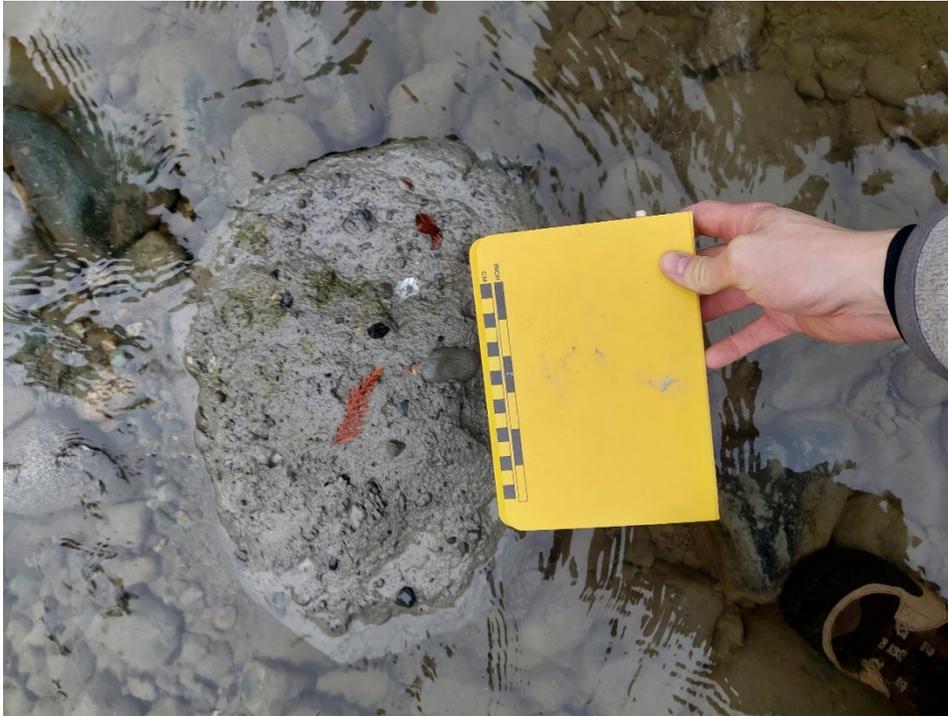
Photo 3.2 Conglomerate of bank material deposited in the channel near RK 8.5.

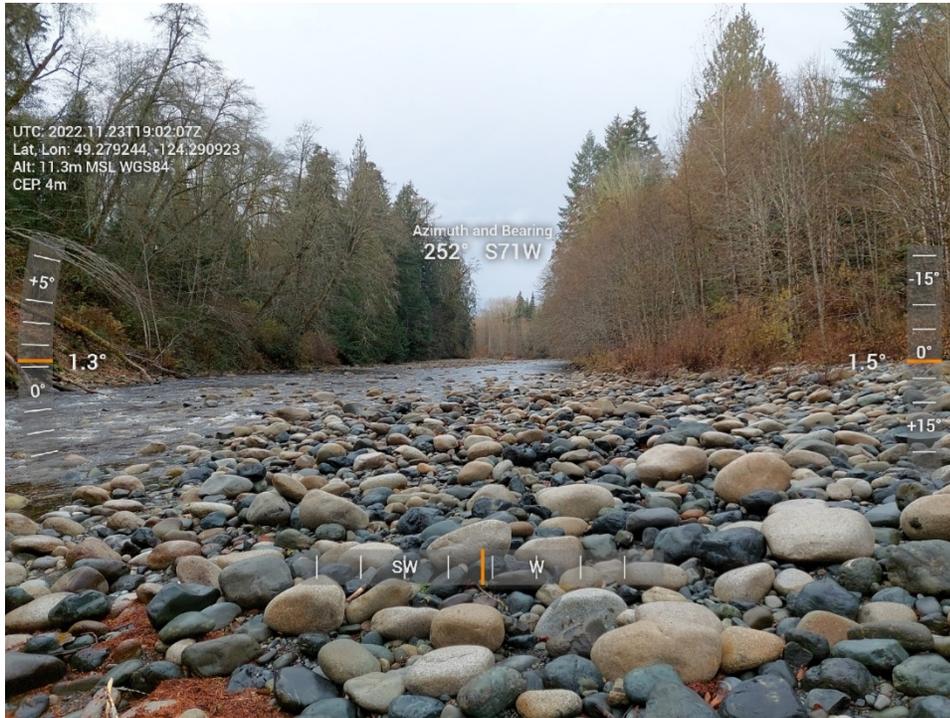
Across from the claybank, a coarse cobble-boulder bar has formed (Photo 3.3). A Wolman count collected at this location shows that the median size of surficial bed material (D_{50}) is 173 mm (cobble) and that the coarse fraction of the bed, as represented by the D_{84} , is 300 mm (boulder). The coarse sediment imparts a degree of stability to the bed, as these particles are likely only mobilized during extreme flood events. The increased resistance to flow provided by this bar may be deflecting higher velocity flows towards the claybank, contributing to the observed bank erosion.

Photo 3.3 Photo is looking upstream at the head of a cobble-boulder bar across from the upstream claybank (RK 8.6).

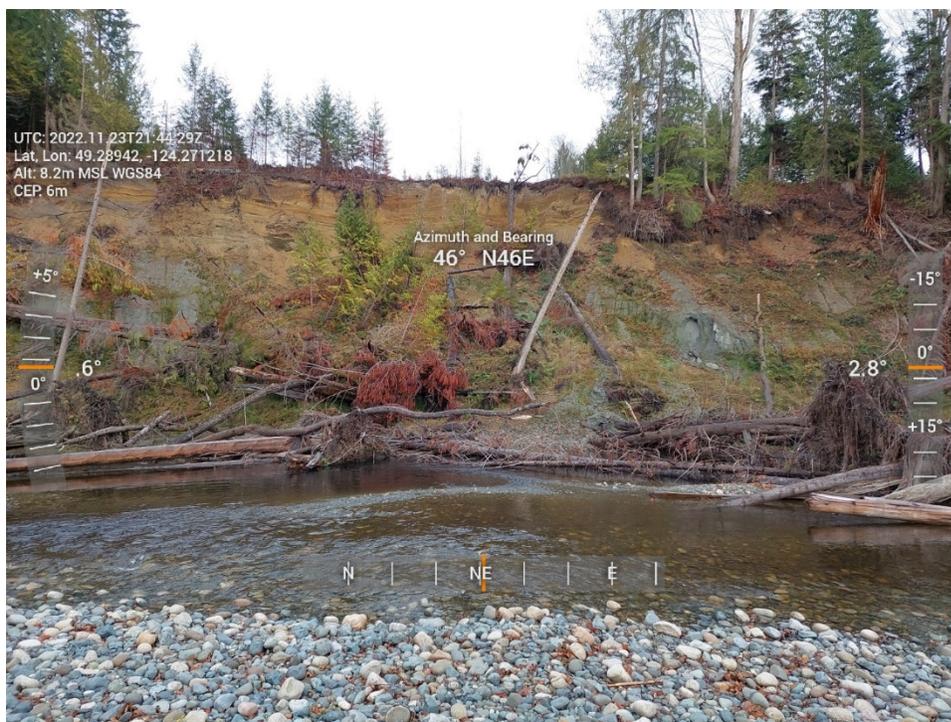
Due to the rapid bank erosion, numerous trees, previously lining the top of bank, have raveled downslope, and accumulated along the slope and toe of the bank. During future flood events, the river is likely to mobilize much of the debris accumulation along the toe of this slope and transport it downstream.

Photo 3.4 Photograph of the downstream eroding claybank (RK 6.3).

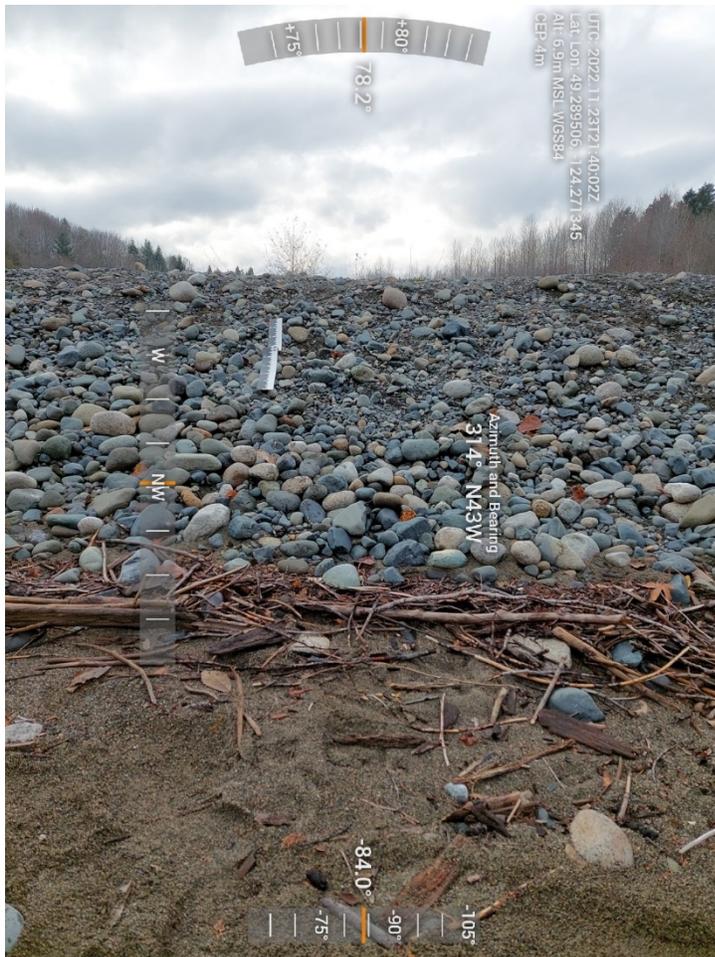
Photo 3.5 Photo looking upstream at the slip face of a migrating bedload sheet on the bar tail near RK 6.3.

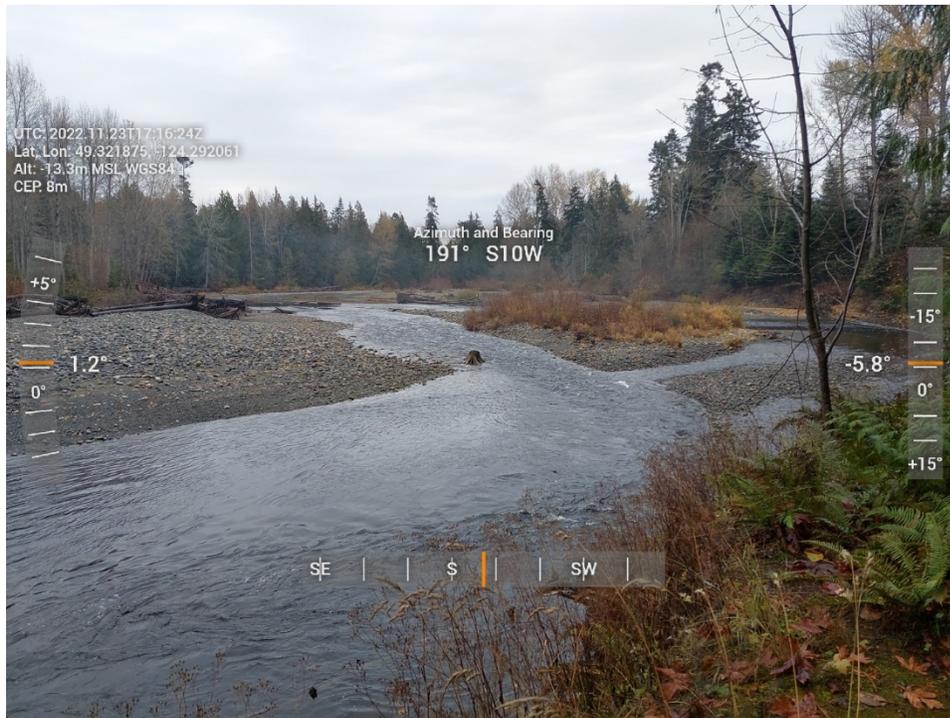
Photo 3.6 Photo looking upstream at the site of a recent channel avulsion upstream of the estuary (RK 1).

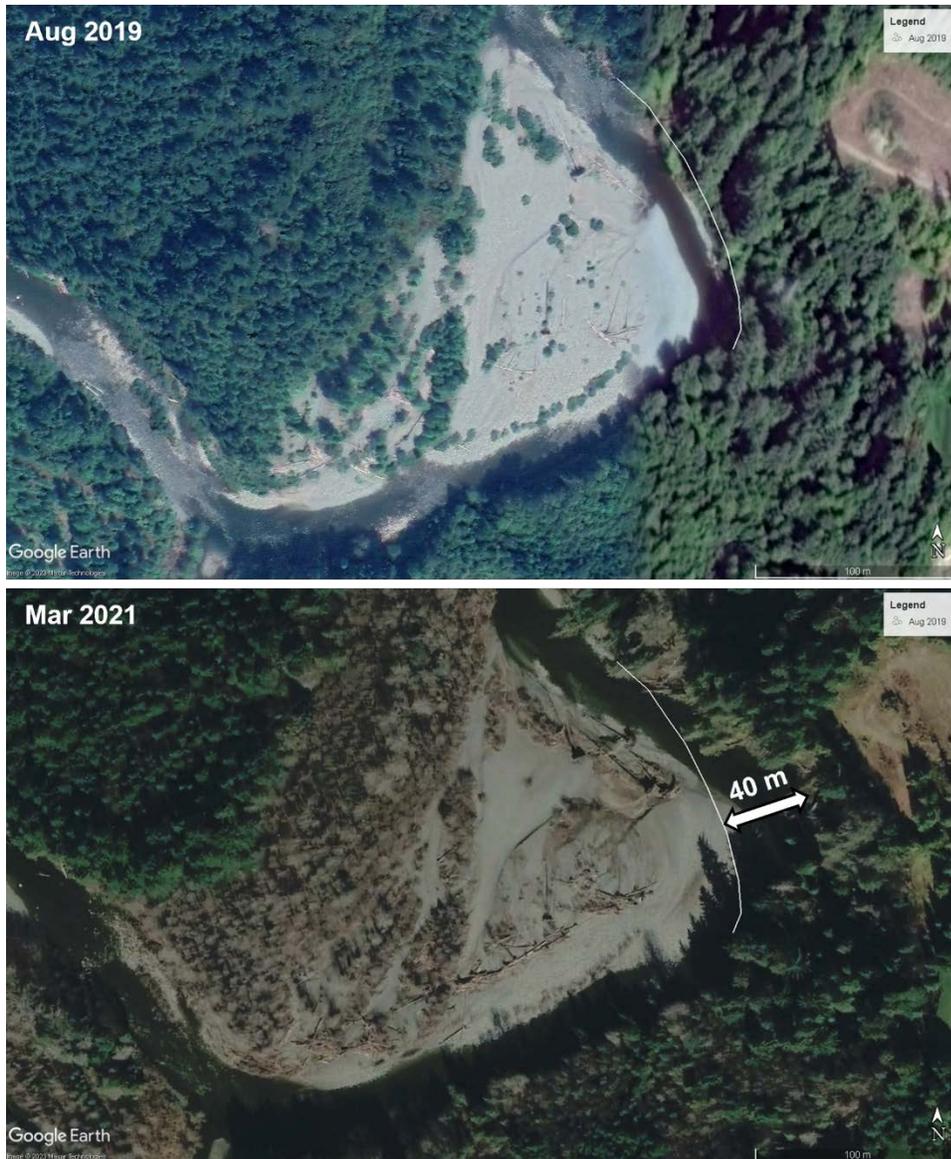
River migration has caused extensive erosion along the downstream claybank. Here, the till bank tends to fail periodically in slabs, while the upper bank ravel much more frequently. The average rate of erosion since 2006 has been 8.5 m/year. This bank poses a risk of high sediment loads to the river. Compared to the upper claybank, this slope exposes less till and more sand and gravel from the Capilano sediments. The till here contains more silt and less fine sand, which, when deposited in downstream channel reaches, may negatively impact habitat quality.

Figure 3.4 Rapid bank erosion at the downstream claybank (RK 6.3) from 2019 to 2021.

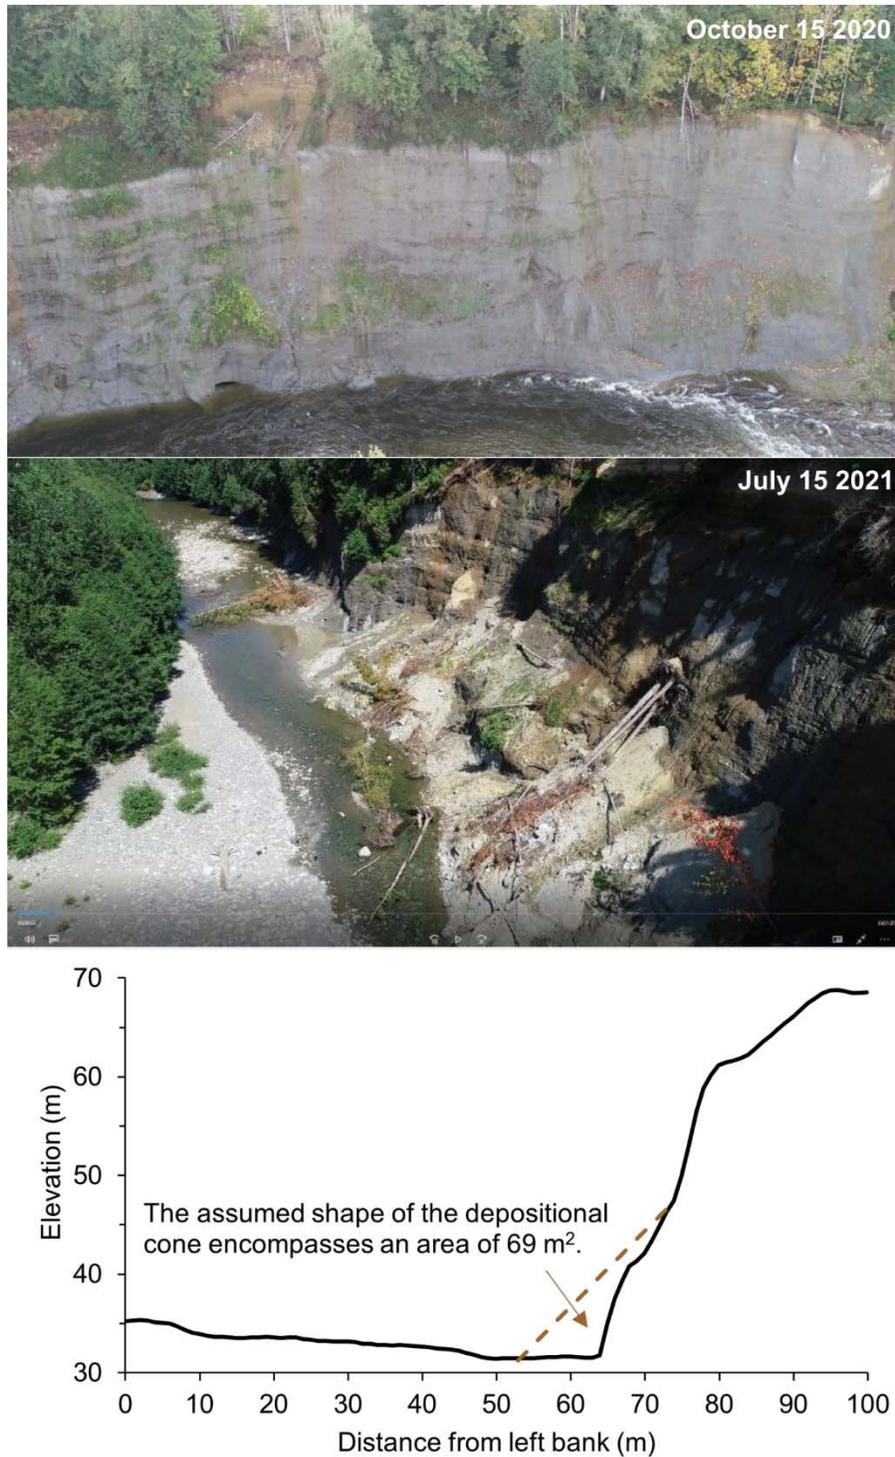
The upstream claybank (RK 8.6) actively contributes sediment to the river channel through both gradual erosion during moderate flows and episodic events during high flows, as well as smaller episodic events during dry periods when there is low pore pressure in the face. One recent example of a large claybank failure occurred in 2021, resulting in the deposition of a substantial volume of fine sediment into the Englishman River. This event can be observed in Figure 3.5, where pre- and post-failure images illustrate the infilling of the pool at slope's base and partial blocking of the channel. By using the 2019 Lidar DEM to model the pre-failure bank topography, we estimate that the failed material covered an area of approximately 69 m^2 for a given cross-section. Extrapolating this over the 100 m length of bank, we estimate a total volume of $6,900 \text{ m}^3$, or 11,700 T. Comparing this to the long-term average sediment yield estimated from regional data (ranging from $4,700$ to $26,200 \text{ m}^3$), suggests that the sediment input

from the 2021 bank failure may have constituted an appreciable portion of the total sediment yield for that year. It is important to note that the deposition of fine sediment during such large events poses potential risks to downstream water quality and fish habitat, as emphasized in communication with J. Damborg (email, April 24, 2023).

Figure 3.5 Example of an episodic large-scale failure at the upstream claybank . Upper panel shows the claybanks prior to failure in 2020 while the middle panel shows the claybanks in July 2021 post-failure. The lower panel shows a cross-section profile of the claybank based on the 2019 Lidar DEM, with an assumed shape and area of the depositional cone.

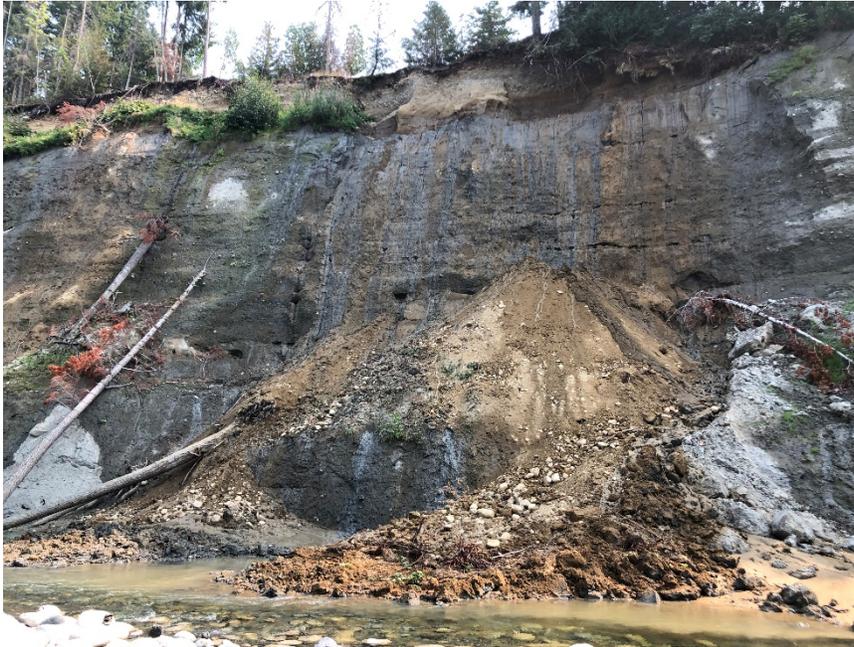
Another recent failure occurred August 26/27, 2023 during low river flow conditions and a dry weather period. This failure was caused by low pore pressure in the face, which decreases cohesion. The over-steepened slope failed contributing clay, silt, sand, and gravel to the river. This episode caused visible siltation in the river in downstream reaches. Photo 3.7 shows the slope failure.

Photo 3.7 A slope failure occurred on August 26/27, 2023 during a dry, low flow period (Photo credit: Mid Vancouver Island Enhancement Society).

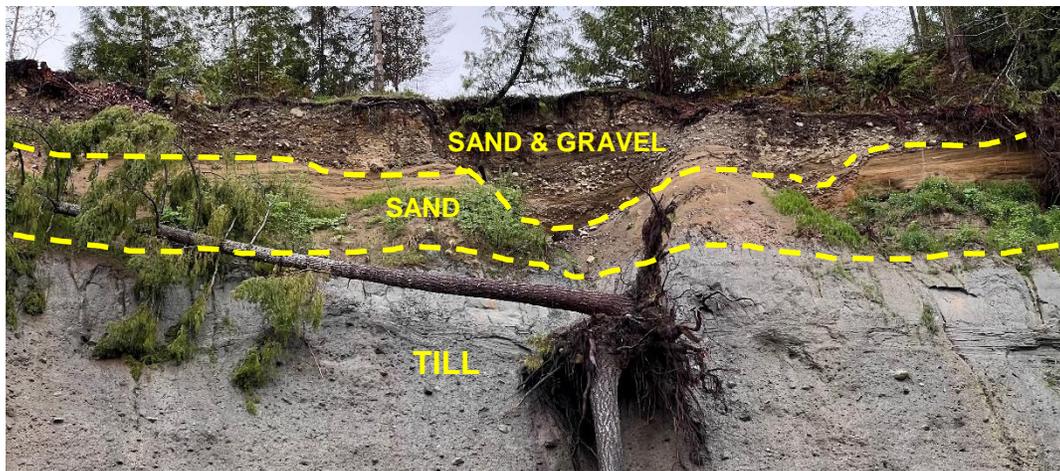
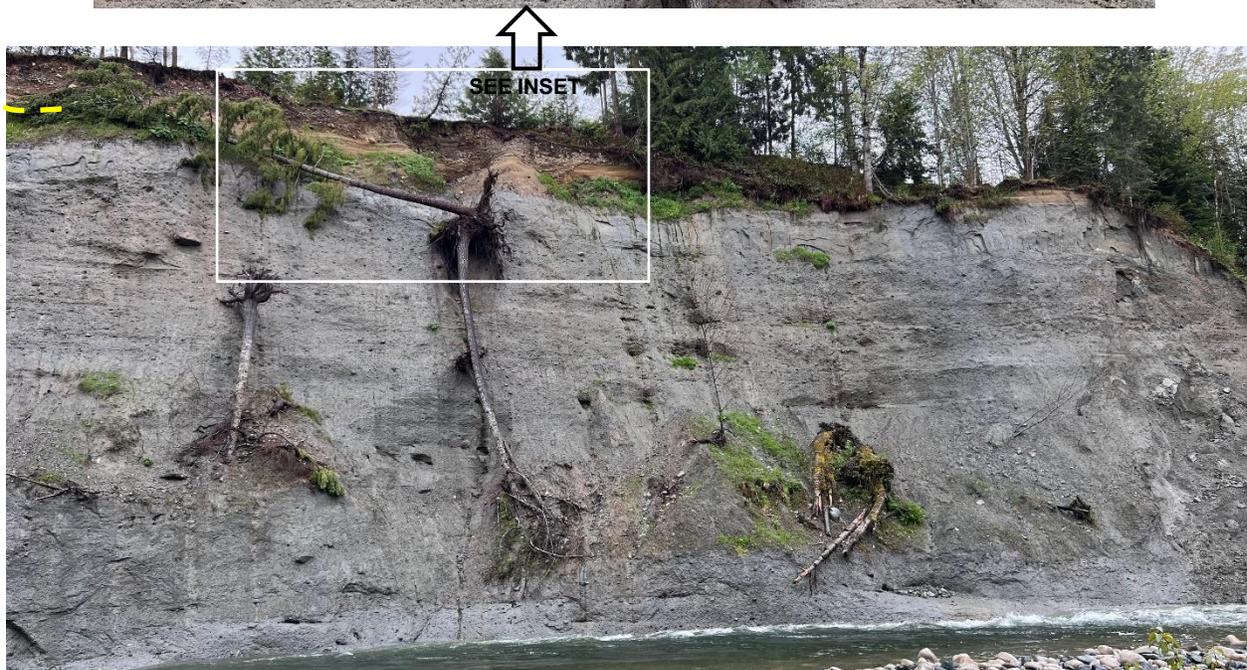
The erosion has undermined several trees along the slope crest, causing them to uproot and fall down the bank. Some trees undoubtedly washed downstream but a few currently

rest precariously along the minor benches, as seen in Photo 1. One of these trees still has green foliage, indicating it has only recently been uprooted.

Photo 1: Upstream Claybank, exposing Capilano sediments overlying till.

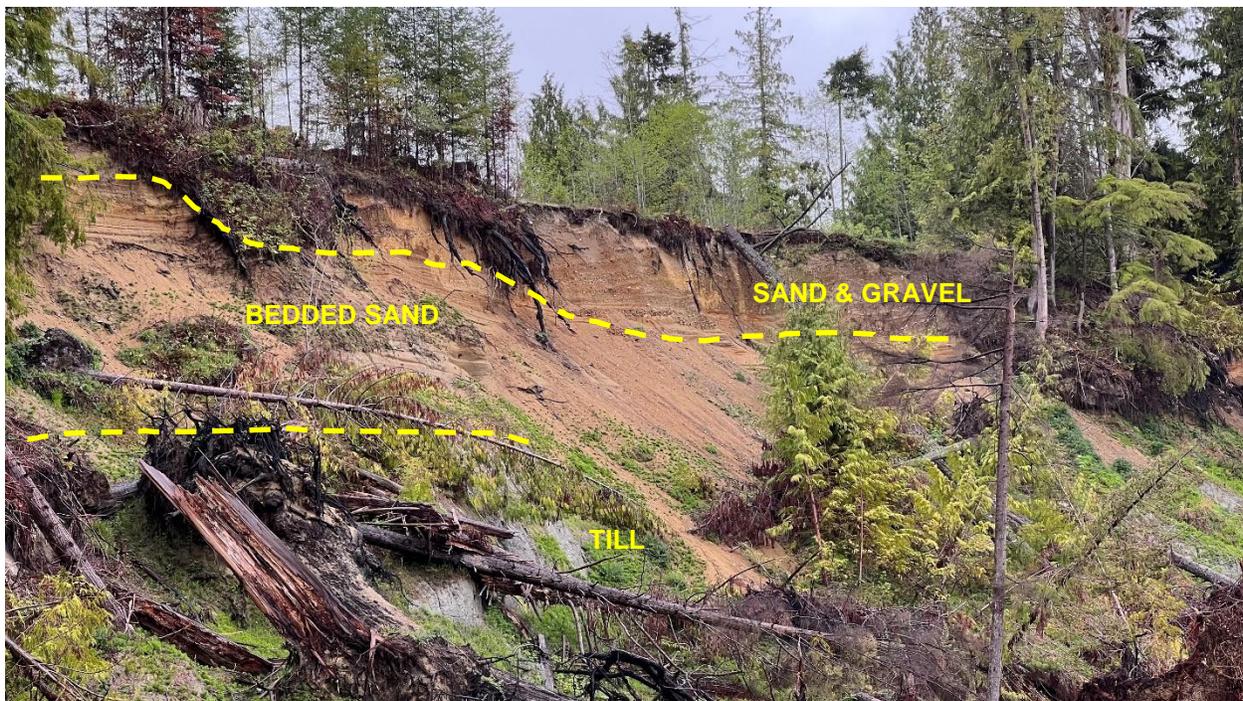
The upper slope is highly over-steepened at 60° or steeper, bare or unvegetated, and actively failing. The slope crest has undermined the thick mat of forest soil, causing several trees to uproot and fall onto the lower slope.

Localized steeper sections along the lower slope expose till at the surface; however, most of the lower slope is covered by the granular colluvium that has failed from the upper slope. This lower slope is at its angle of repose estimated to be roughly 36°, and is lightly vegetated with grasses, sedges, and horsetail.

Photo 2: Downstream Claybank exposing thicker Capilano sediments over till.

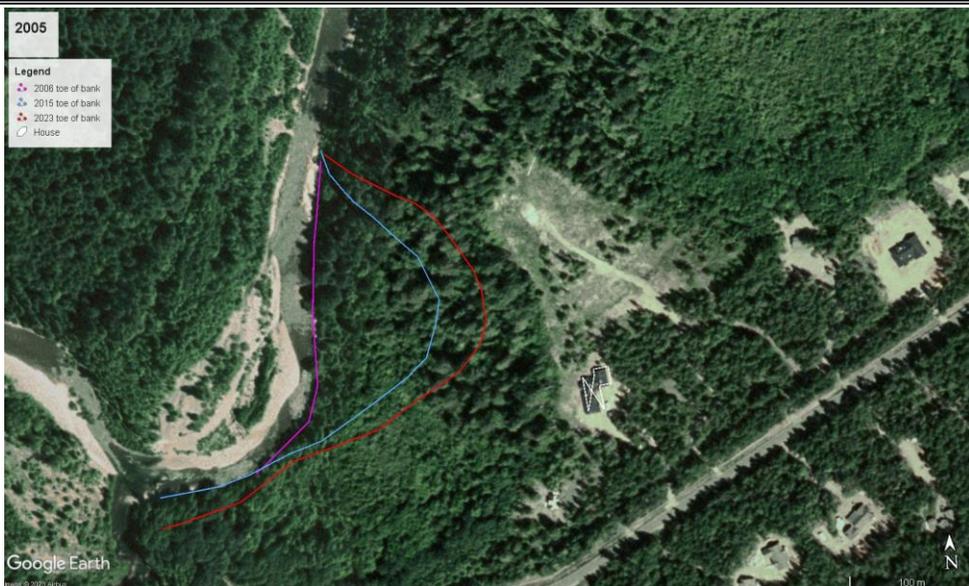
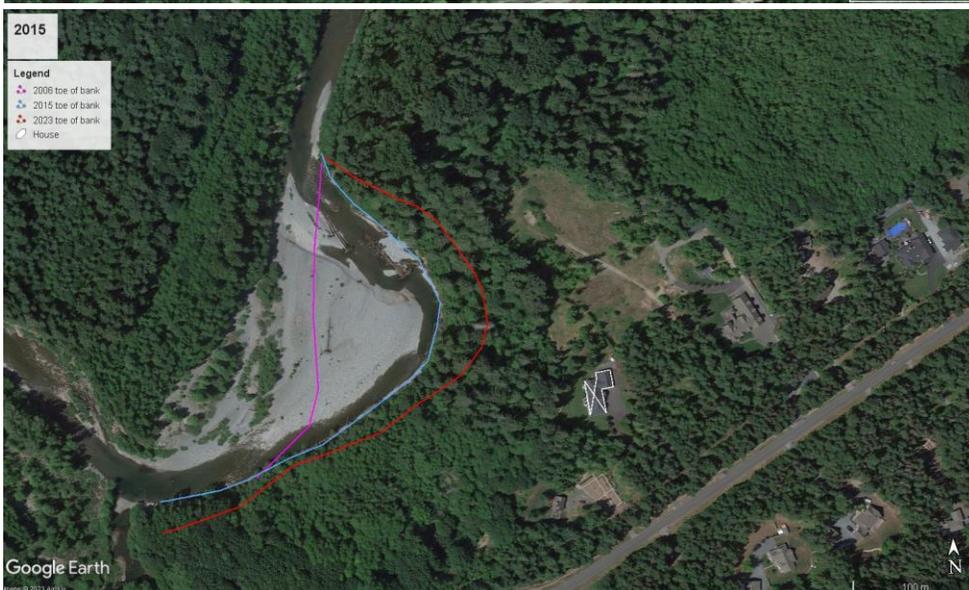
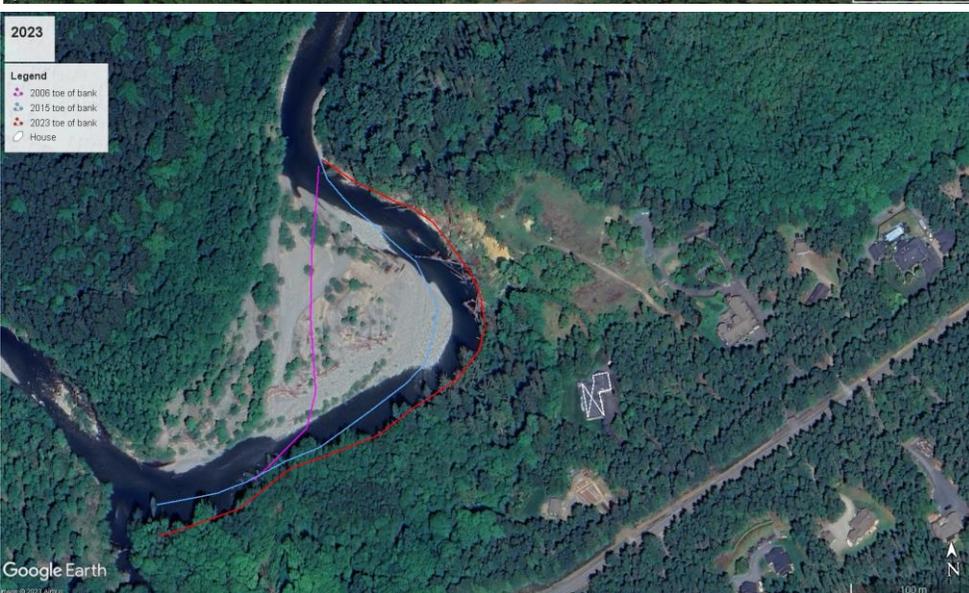
Google Earth images showing the approximate edge of the river bank at selected years.

Location of slope crest adjacent to house is unknown. Set back was not measured.
