NHC Ref. No. 03000133

**MID VANCOUVER ISLAND HABITAT ENHANCEMENT SOCIETY**PO Box 935  
Parksville, BC  
V9P 2G9**Attention: Ms. Faye Smith**  
Project Coordinator**Via email:** [fsmith@telus.net](mailto:fsmith@telus.net)**Re: Shelly Creek Geomorphic Overview and Conceptual Level Habitat Enhancement Program Development**

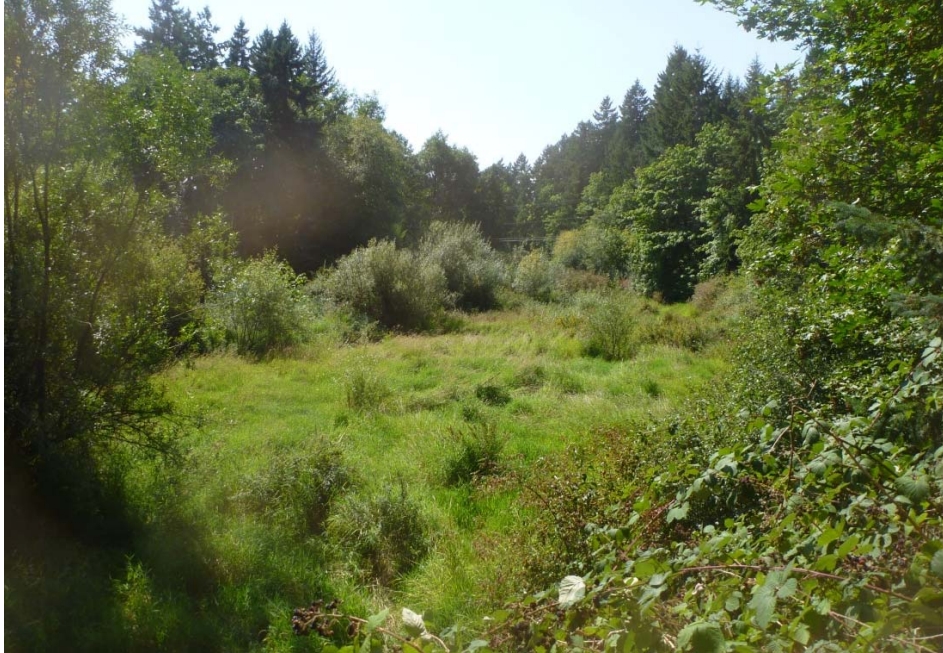
Reach 1 is a low gradient marshland that extends 220 m between Martindale Road and the Englishman River (**Photo 1**). Typically this reach is about 45 to 50 m wide. The downstream end is partially impounded by moraine deposits comprised of lenses of gravel sand and silt which forms a 1 to 2 m high berm. The channel drains through the berm and into the Englishman River in a steeply incised channel that is only a few metres (**Photo 2**).

**Photo 1. View of Reach 1 marshland**

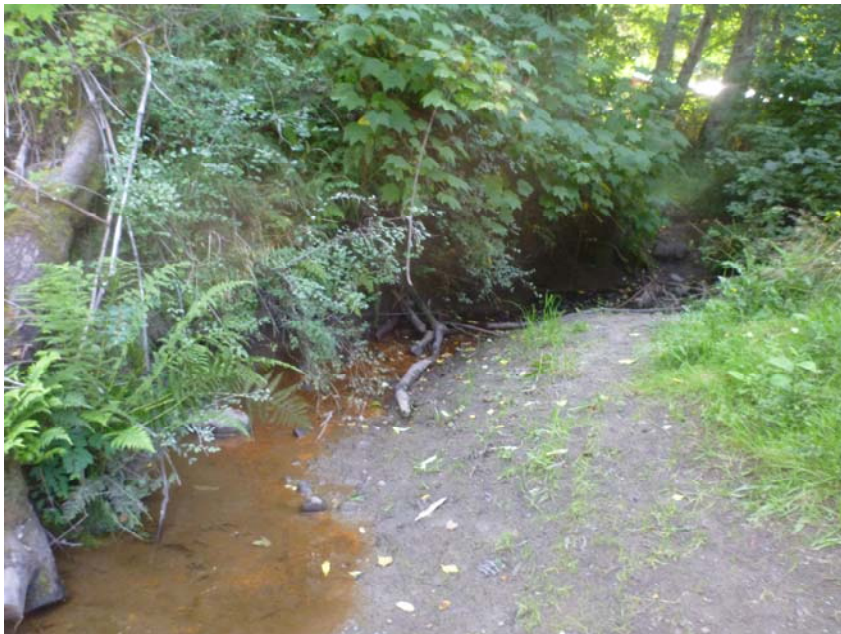
**Photo 2. Upstream view of Shelly Creek at the confluence with the Englishman River**

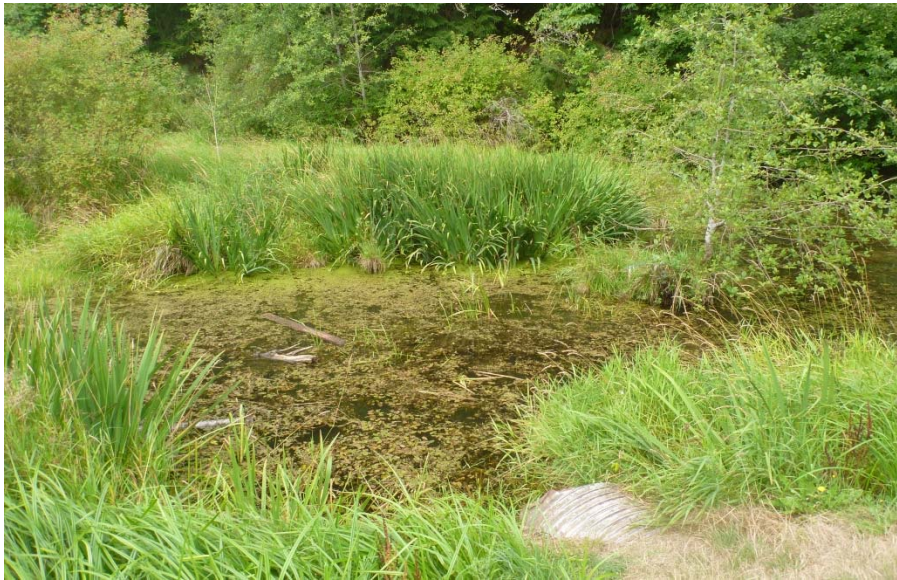
Reach 2 extends upstream of Martindale Road for a distance of about 400 m. Immediately upstream of Martindale Road is a pool that is roughly 30 m wide by 50 m long. Fine sediment deposition has partially filled in the pool and has facilitated the colonization of vegetation (**Photo 3**). Upstream of the pond the channel is typically 15 to 20 m wide with a poorly defined and densely vegetated right bank and a left channel edge that is confined by a steep terrace.

**Photo 3. View of pond upstream of Martindale Road**

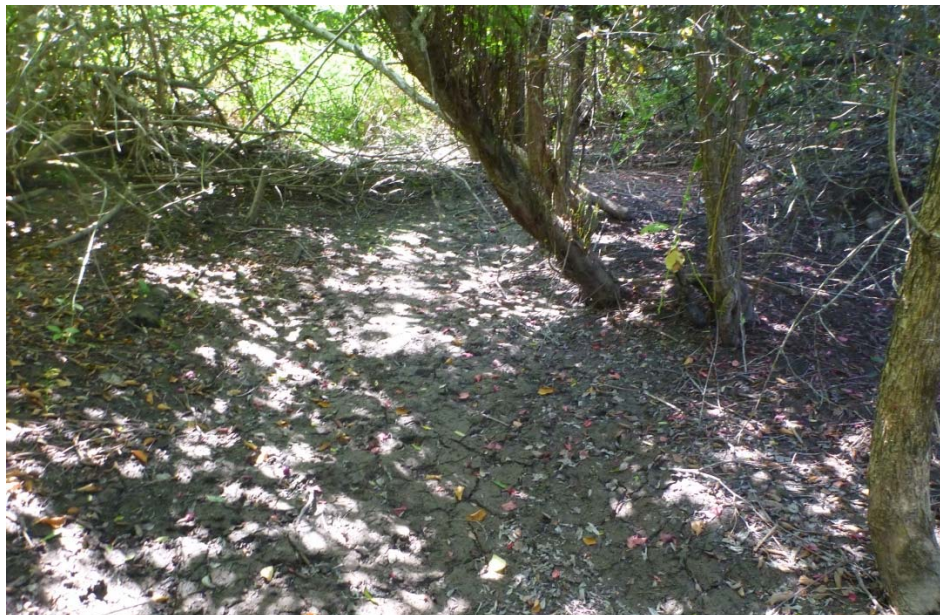
The channel is occasionally incised into the adjacent field and the bed is covered with fine sediment (**Photo 4**). The upper end of the reach is defined by a steep terrace that is up to 5 m high and forms a barrier to fish passage. The channel was likely aligned differently prior to settlement by man and the steep drop may be a direct result of channel realignment for farming and settlement purposes. The terrace is severely eroded and a steep gully has formed at the downstream end of a culvert that drains from Reach 4.

Photo 4. View of Shelly Creek downstream of the falls (20 August, 2014)

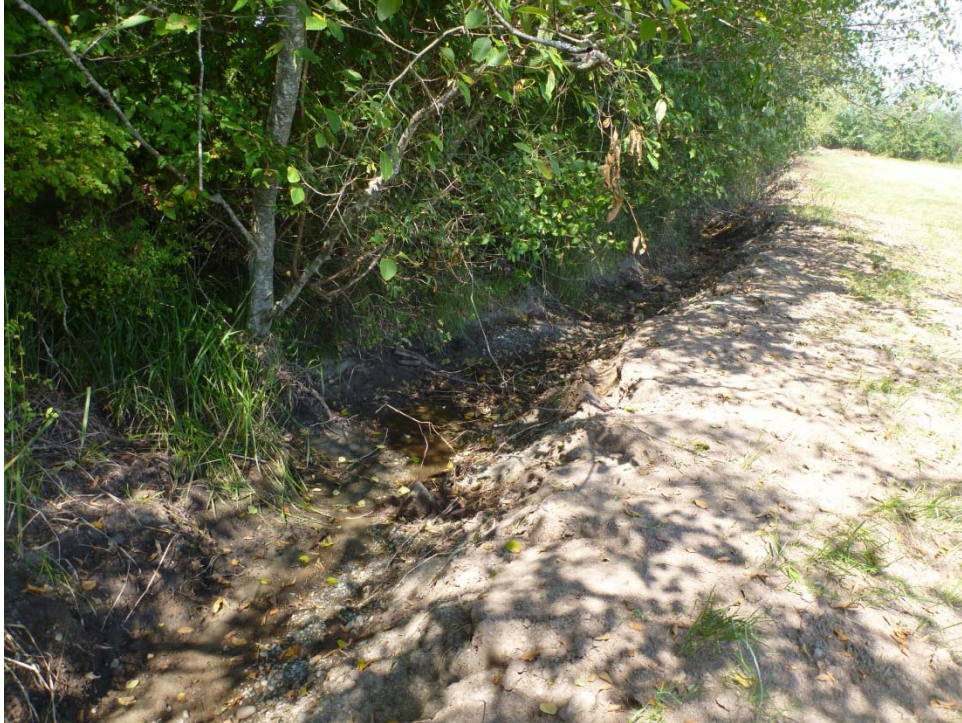
bare or grass covered along the left bank (**Photo 5**). A ditch drains into the channel at the bend in the creek and conveys surface and intercepted ground water from the western field and surface runoff from Blower Road. The channel bed is mostly covered with gravel deposits and the channel has cut through the upper soil layer and exposed the marine clay veneer in places.

**Photo 5. Downstream view of Shelly Creek**

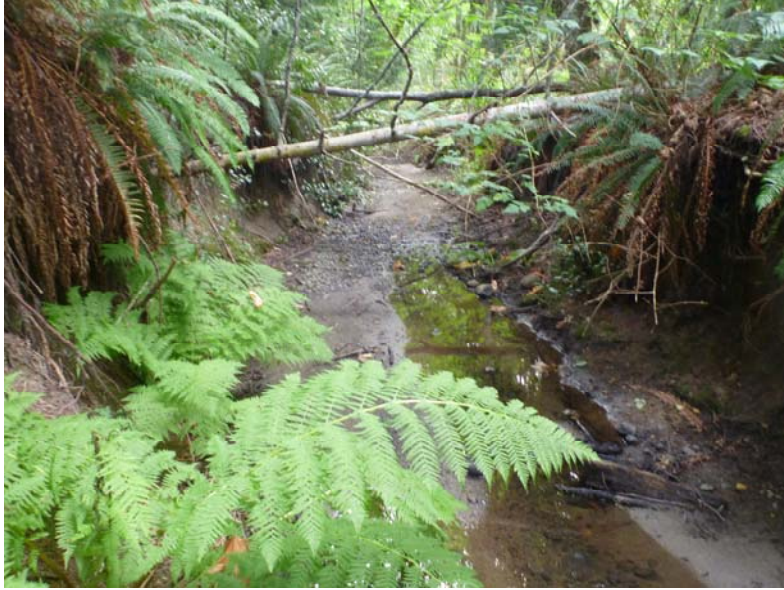
Downstream progressing head cutting is evident, starting at the outlet of the culvert that crosses Blower Road and the channel is steeply incised into easily erodible fine grained marine sediment by more than 2 m at the upstream end (**Photo 6**). Exposures of relatively resistant marine clay on the channel bed toward the downstream end of the reach have limited the extent of channel incision. The banks are typically less than 0.5 m (**Photo 7**) and overbank flooding occurs regularly (Bud Shelly 20 August, 2014 personal communication). The gradient decreases near the lower end of this reach and the bed is covered with a thick layer of gravel deposits.

**Photo 6. Upstream view of steeply incised channel downstream of Blower Road**

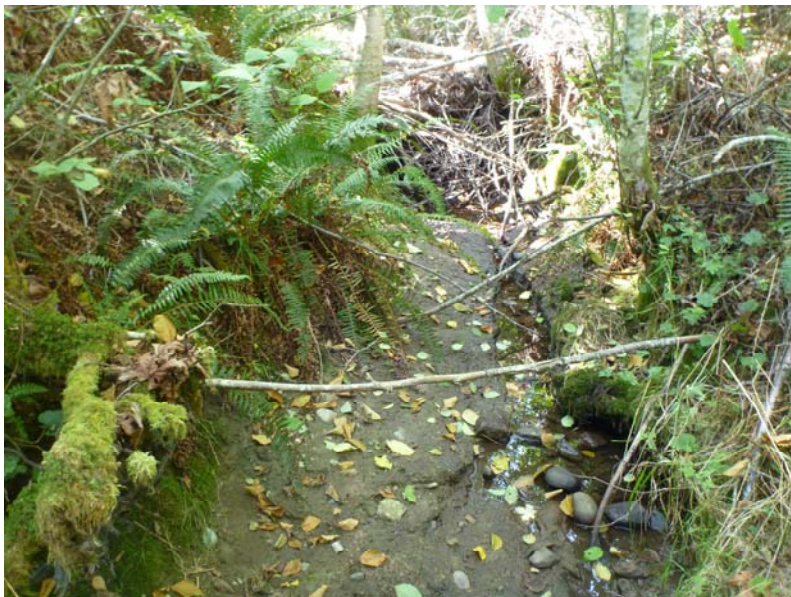
**Photo 7. Downstream view of channel near downstream end of Reach 5**

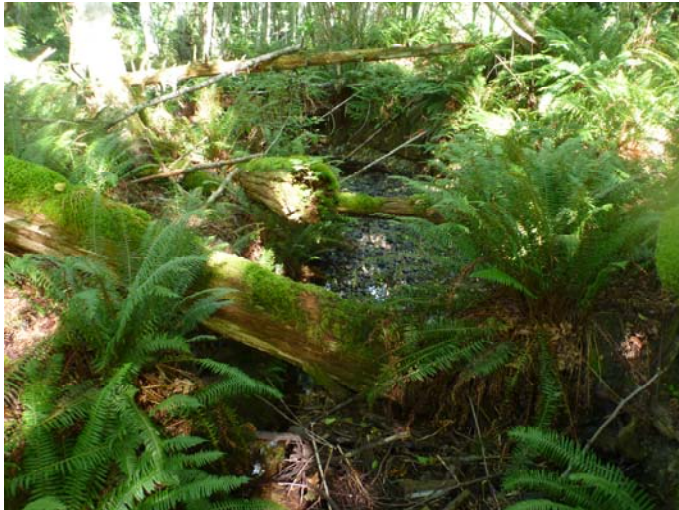
With an average gradient of about 3%, Reach 6 is significantly steeper than the Reaches 1 to 5, which have an average gradient of 0.5% or less. The Reach 6 bed is vertically controlled at three locations by culverts: at the upstream end at Butler Avenue, approximately mid reach, and at the downstream end at Blower Road. Large woody debris also functions to maintain the channel gradient and structure (**Photo 8** and **Photo 9**).

**Photo 8. Downstream view of Shelly Creek near Blower Road**

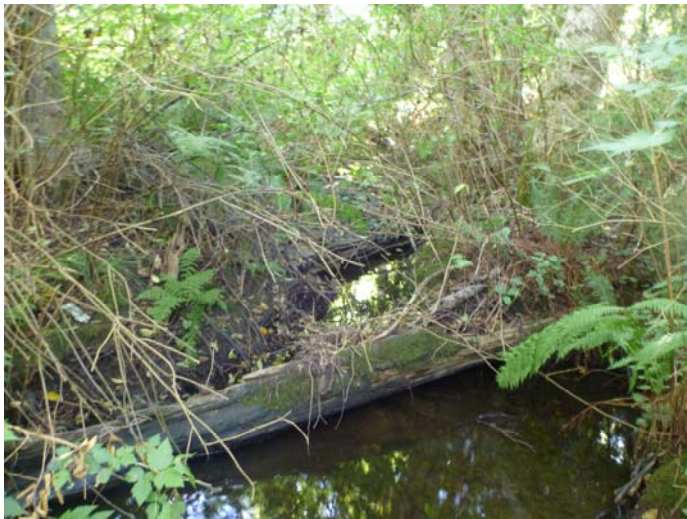
**Photo 9. Downstream view of Shelly Creek near Butler Avenue**

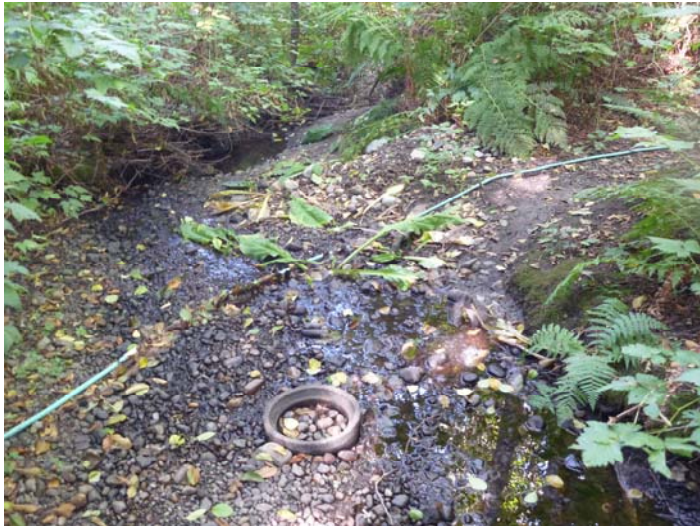
Immediately downstream of Butler Avenue the channel is relatively unconfined and the banks are poorly defined and low. Water hoses and sumps buried into the channel bed suggest that some unlicensed water withdrawal is occurring (**Photo 10**). Approximately 80 m downstream of Butler Avenue, the

channel gradient increases and becomes incised by up to 2 m at the left bank. Locations such as this are significant point sources of fine material to the system.

**Photo 10. Downstream view of Shelly Creek just downstream of Butler Avenue**

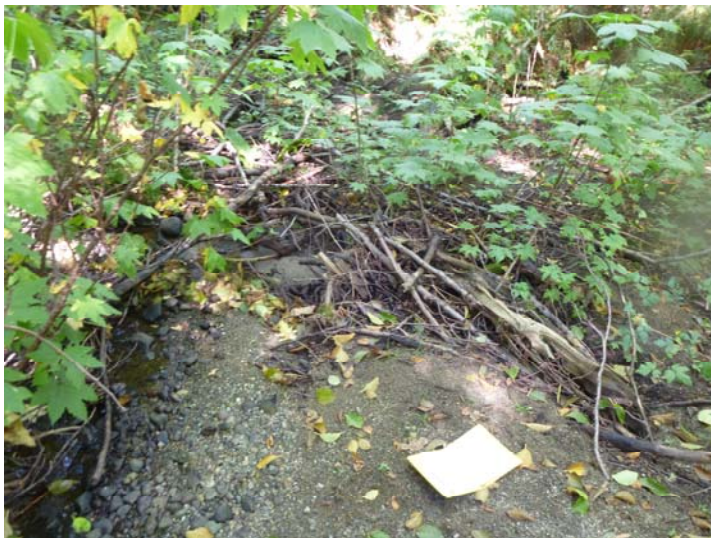
Channel bed material typically ranges from fine gravel to small cobbles. Fine sediment deposits are commonly found upstream of channel blockages that are created by dense accumulations of small woody and large debris, vegetation, and mobile bed material (**Photo 11**). Large accumulations of fine gravel immediately upstream of the mid reach culvert and the Blower Road culvert indicate that they are undersized.

**Photo 11. Deposits of fine sediment upstream of channel blockages (view looking downstream)**

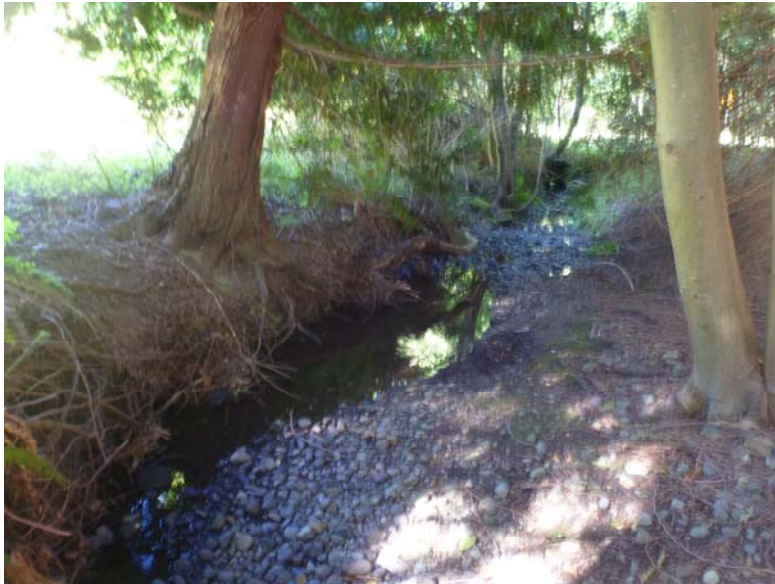
Reach 7 extends 140 m between Butler Avenue and Hamilton Avenue along an entrenched channel with bank heights of 1 to 2 m and a gradient of about 3%. The channel banks are sparsely vegetated, and banks are typically unstable and undercut, and the channel is devoid of any large woody debris. Grade is controlled at the downstream end by an undersized culvert that is causing gravel to accumulate at the inlet (**Photo 12**). A storm drain, roughly 850 mm diameter, drains from the Corfield Glades subdivision directly into Shelly Creek approximately 100 m upstream of Butler Avenue and the right bank is severely eroded immediately downstream of the outlet.

**Photo 12. Downstream view of Shelly Creek at Butler Avenue**

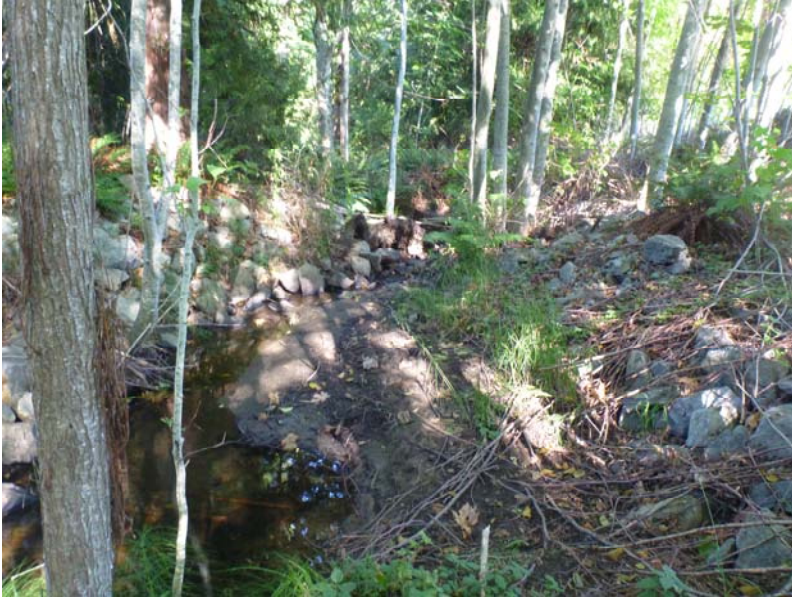
From the upstream end of this reach, at Hamilton Avenue, to the Corfield Glades storm drain the channel is confined by riprap bank protection along the left side and the base of Hamilton Road along the right. The riparian area is sparsely vegetated with low growing vegetation and young alders (**Photo 13**) and is absent of large woody debris. The creek crossing at Hamilton Road was replaced in 1999 (Faye Smith, 20 August, 2014 personal communication) with a large double box culvert that conveys is tied into the Hamilton Avenue storm water system. Immediately downstream of the outlet the channel widens to 4 to 6 m and the bed is covered with fine sediments.

**Photo 13. Downstream view of Shelly Creek between storm drain and Hamilton Avenue**

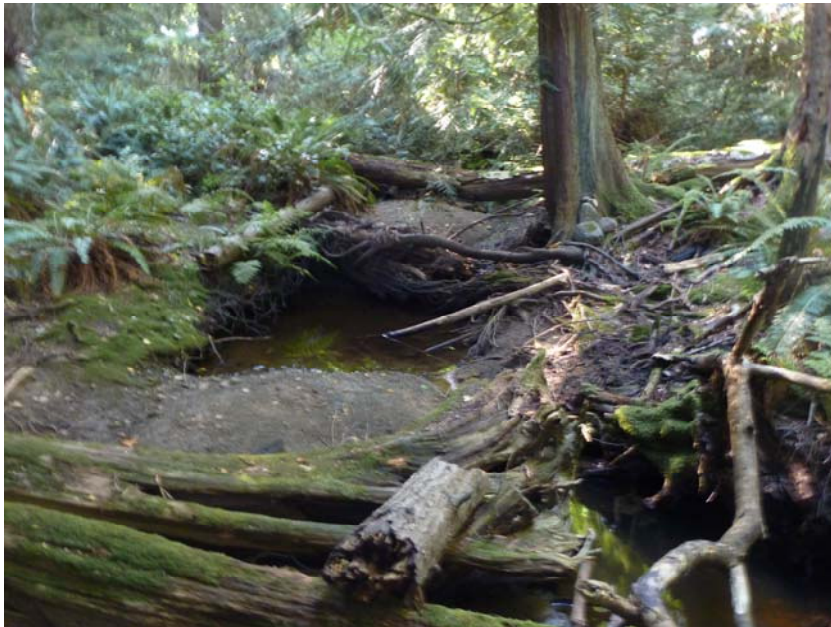
Reach 8 is about 400 m long and extends from Hamilton Road to Wildgreen Way. Most of it flows within a natural riparian setting and even though the average channel gradient is 4% the channel is heavily influenced by logs, boulders, and tree roots that have formed a step-pool channel morphology (**Photo 14**).

**Photo 14. Upstream view of Shelly Creek**

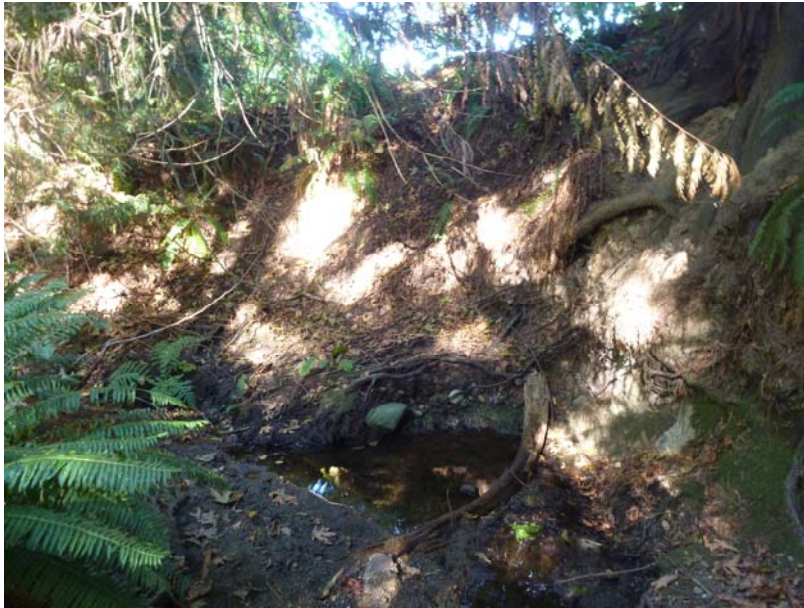
Eroding banks at several locations along this reach supply a significant volume of fine and coarse sediment (**Photo 15**), some of which is transported through the system to lower reaches and some of which is accumulating upstream of channel blockages and filling in valuable pool habitat. Deposits of material at the culverts passing under the railway (**Photo 16**) and Wildgreen Way (**Photo 17**) indicate that the steeper gradient upstream reaches are capable of conveying large cobbles and other coarse grained material in significant volumes.

**Photo 15. View of 3 m high eroding right bank**

Eroding banks are a significant source of fine sediment, particularly in Reaches 3 to 8. These point sources range from less than one metre to tens of metres in length and less than a half metre to three or more metres in height. Banks stabilization takes three general forms: rock armour, vegetation, and

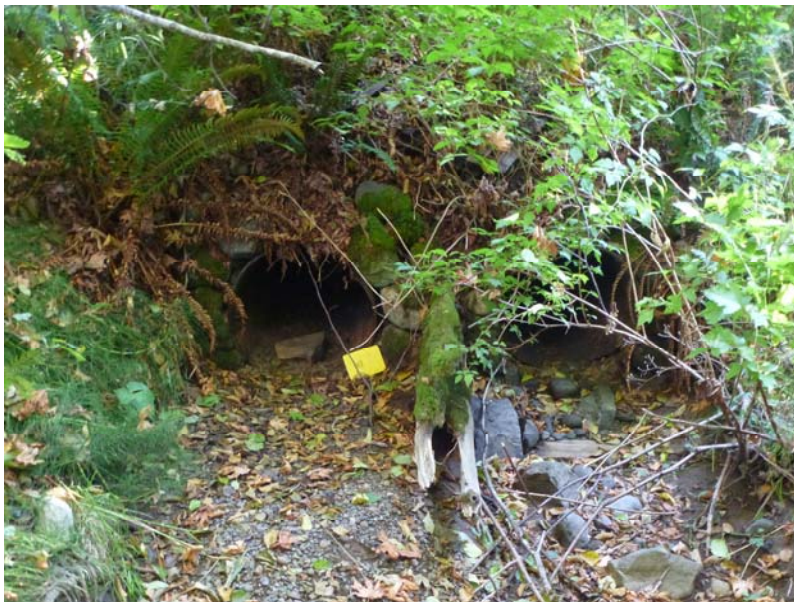
**Photo 16. Upstream view towards culverts crossing under the railway**

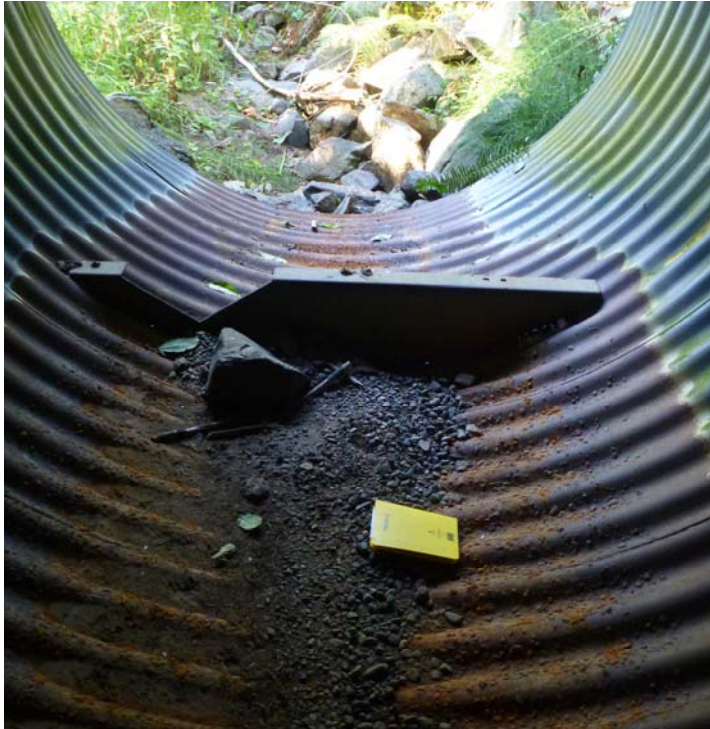
**Photo 17. Downstream view from inside the Wildgreen Way culvert**

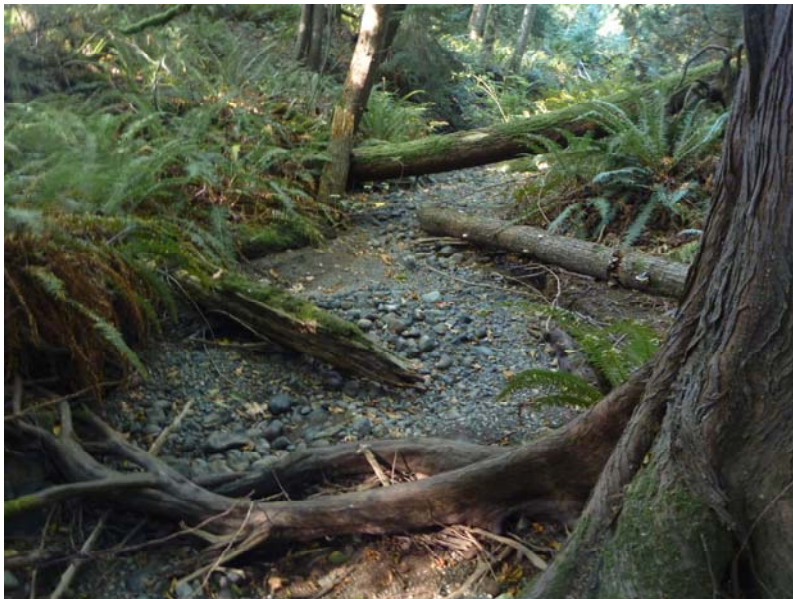
This coarse material will eventually be transported further downstream and will deposit behind large woody debris and other blockages. In places it has almost completely filled the channel and has buried channel habitat features (**Photo 18**).

**Photo 18. Downstream view of sediment deposition**

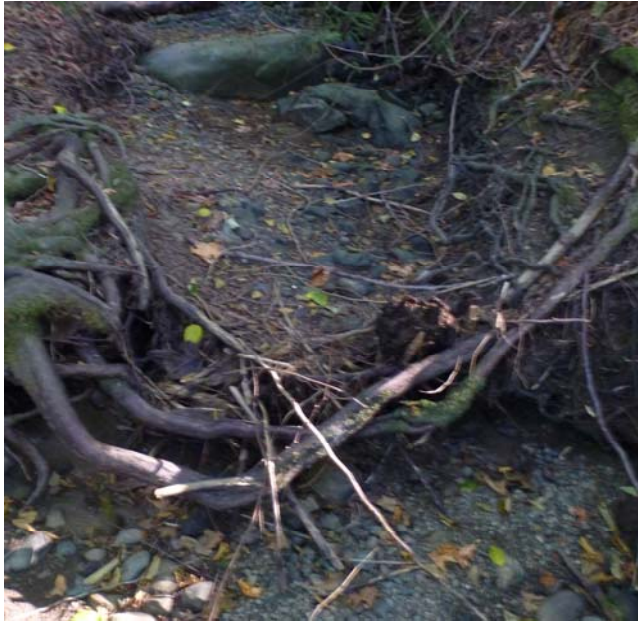
Immediately downstream of the railway crossing the channel the channel gradient increases and has incised by as much as 2 to 3 m. Downstream progressing channel incision is limited by tree roots, boulders and large wood y debris that has created a step-pool transition (**Photo 19**).

**Photo 19. Upstream view of Shelly Creek**

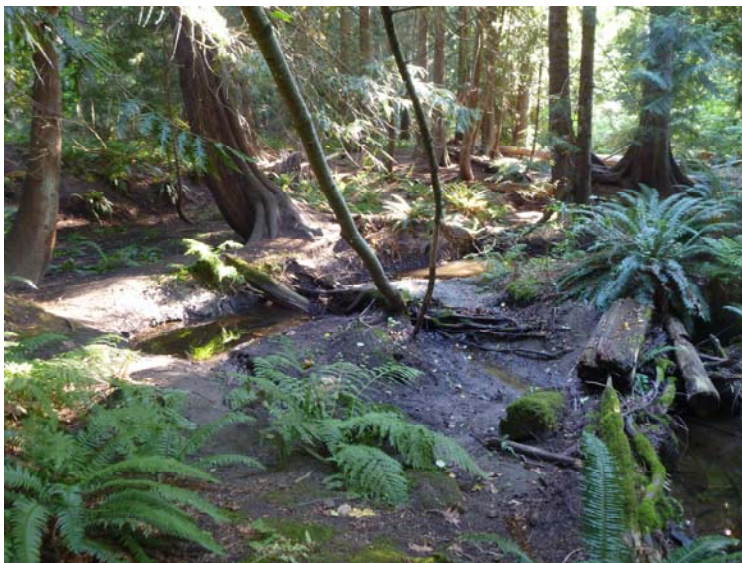
Near the midpoint of this reach the channel transitions to a flat bench and opens into a broad floodplain with low banks, relatively sparse streamside vegetation, and signs of overbank flooding (**Photo 20**). This low gradient, unconfined location creates optimal conditions for deposition of suspended sediment, which has covered the creek bed with fine grained material.

**Photo 20. Upstream view from unconfined channel section**

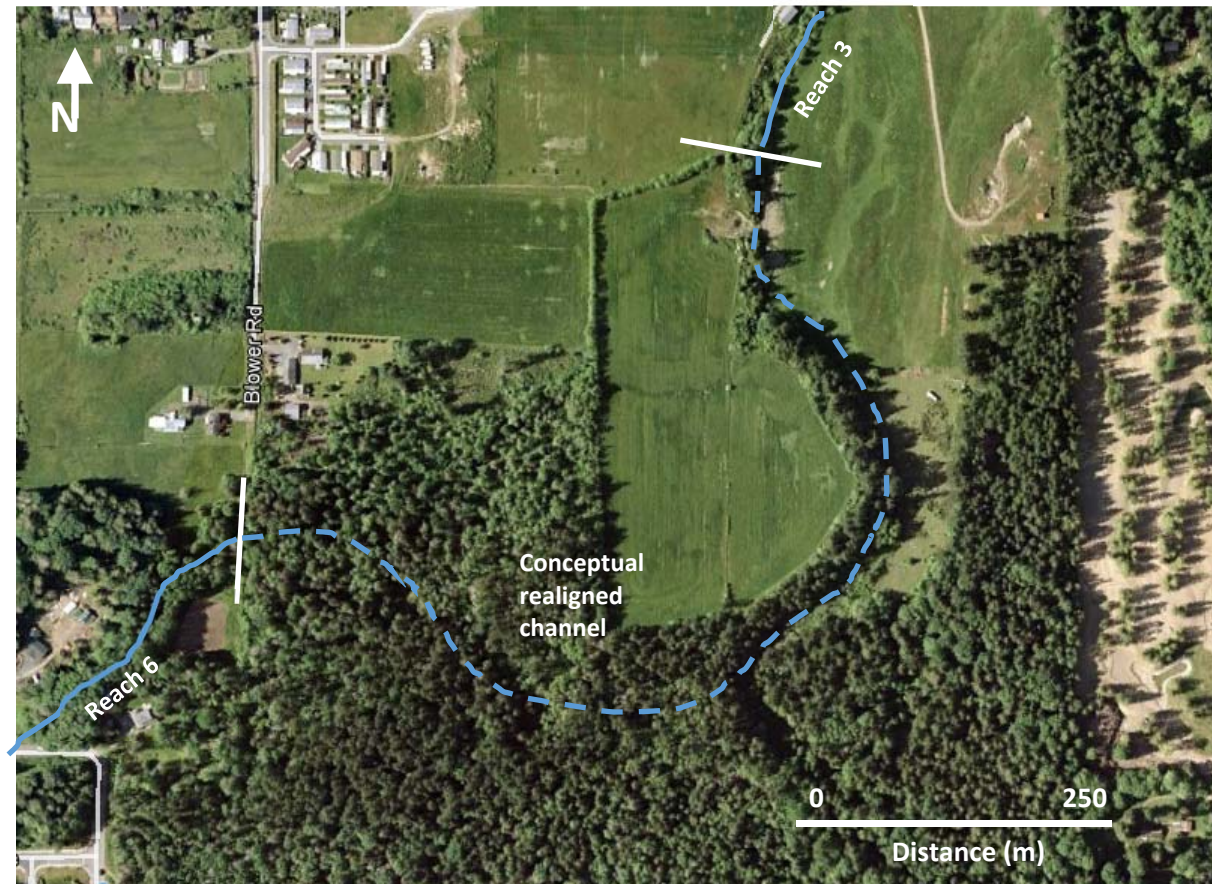
Once of the major factors that limits amount of usable salmonid habitat in Shelly Creek is the 6 m high vertical drop and the upstream end of Reach 3 which prevents fish passage. In order to remove the fish barrier, it is necessary to lengthen the channel and create a series of step-pools that can be navigated by fish (**Figure 3**).

**Figure 3. Conceptual channel realignment**

The realignment of Reaches 4 and 5 would significantly increase the channel length so the channel could transition the 8 to 9 m elevation difference between the upstream end of Reach 5 and the upstream end of Reach 3 with no fish barriers. Construction of a new channel would also alleviate much of the existing sedimentation and flooding issues on the farm and would utilize non-productive farmland. It is estimated that it would cost in the range of \$30 to \$70 per m<sup>2</sup> to realign Shelly Creek and install habitat features.
