Morison Creek Habitat Survey – 2018

On behalf of
Mid Vancouver Island Enhancement Society
(MVIHES)

January 2019

Written By D.R. Clough Consulting

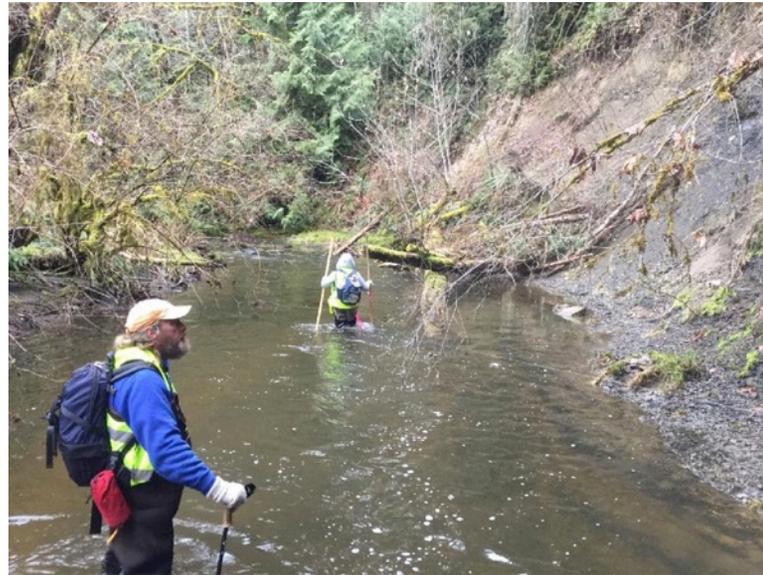
4.) Pool 16 at old erosion site

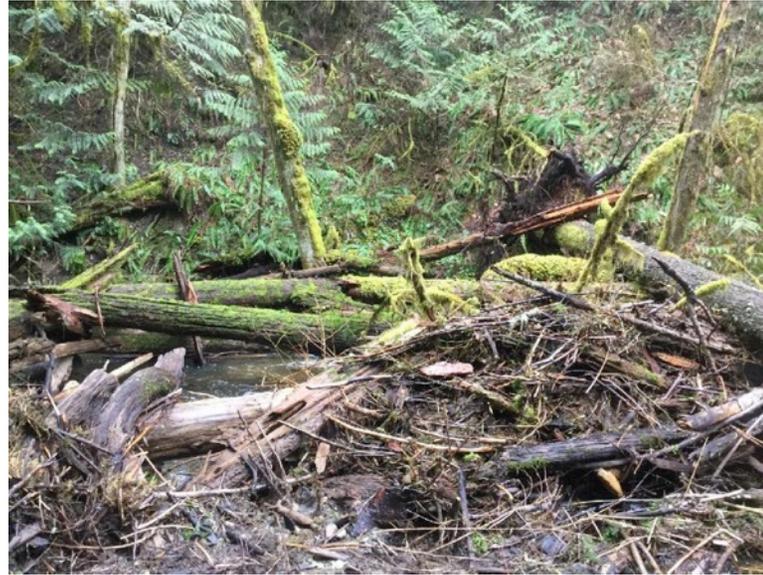
This reach had one significant bank erosion area just above Baxter Falls where approximately 30m of treed bank had slid down over the underlying bedrock into the channel creating a jam. The cause of the slide does not appear to have been aggravated by any recent human developments; an area of thin soils and poorly established roots. The consequence has been some opposite bank erosion and overflowing into a treed area which may cause more failure. The benefit of the slide was the introduction of considerable LWD creating the best fish cover we had observed in the lower river. A beaver had taken up residence and was using the wood material as foundation for a dam that will invariably blow out in winter.

- River right bank failure created considerable erosion and sediment and may create more.
- Poor mean depth (0.4m) in winter indicates limited summer flow habitat
- No off channel refuge areas in the canyon during winter floods

2.) Pool 2 at jam created by right bank slide

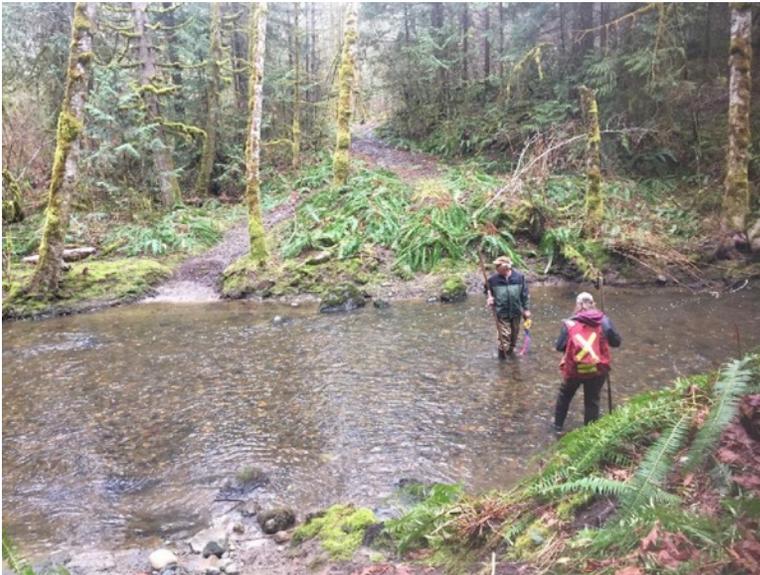
3.) Stagdowne Trail Crossing at Riffle 5

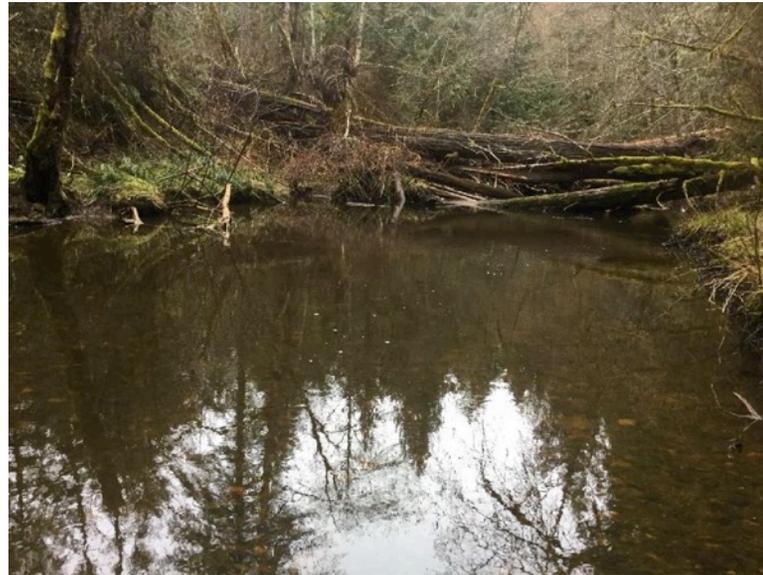
4.) Beaver dam pool 4

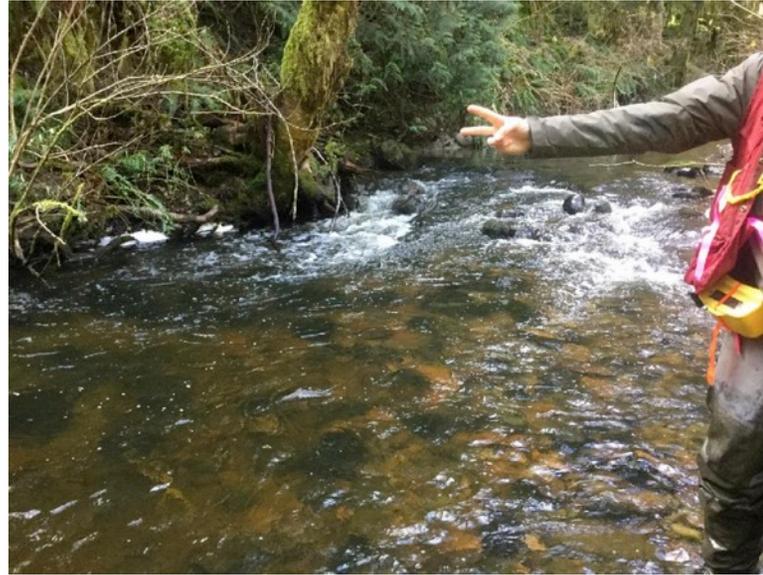
2.) Pool 2 in Reach 3 with Alder rootwad

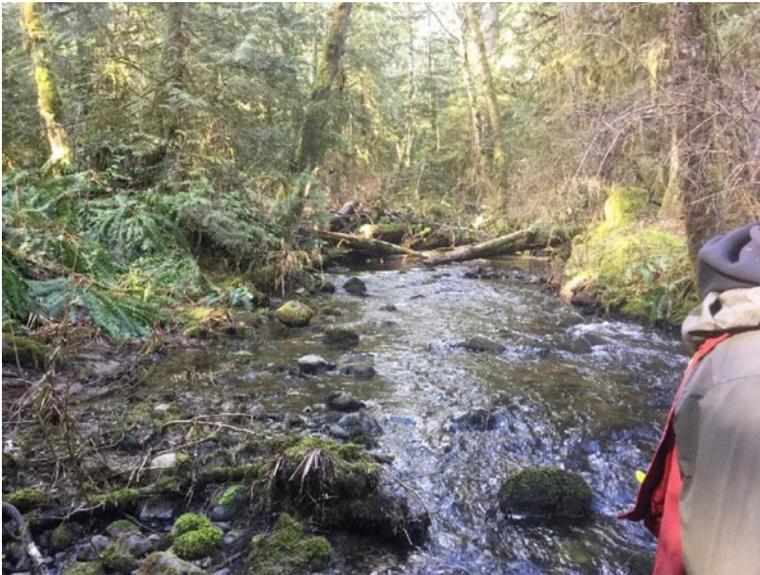
3.) Typical riffle with Alder canopy and debris

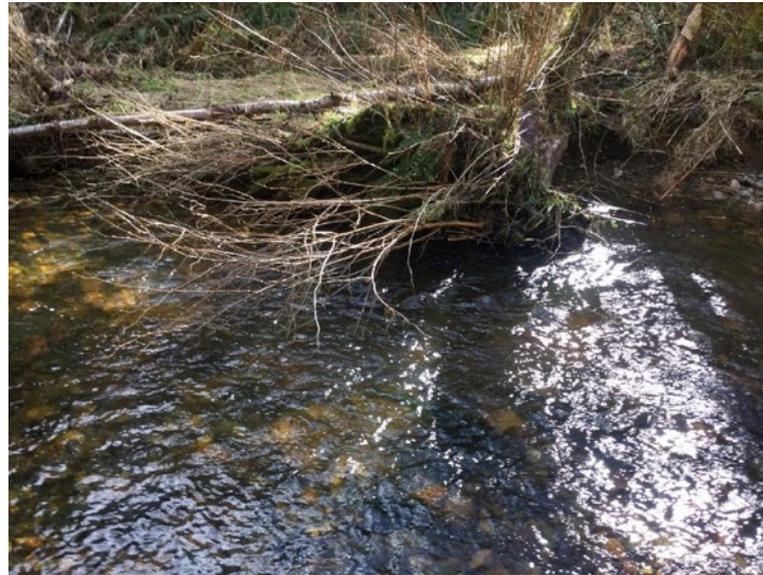
4.) Brush and Alder roots provide pool cover

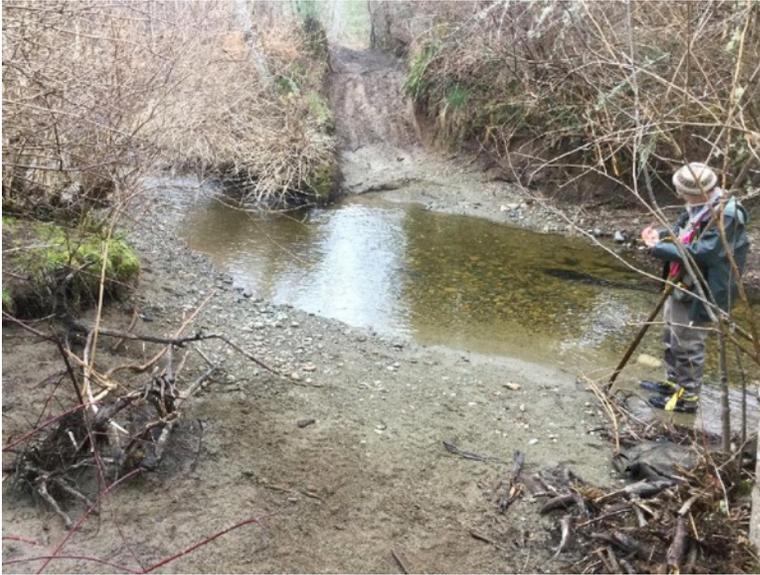
1.) Reach 4a at quad trail crossing

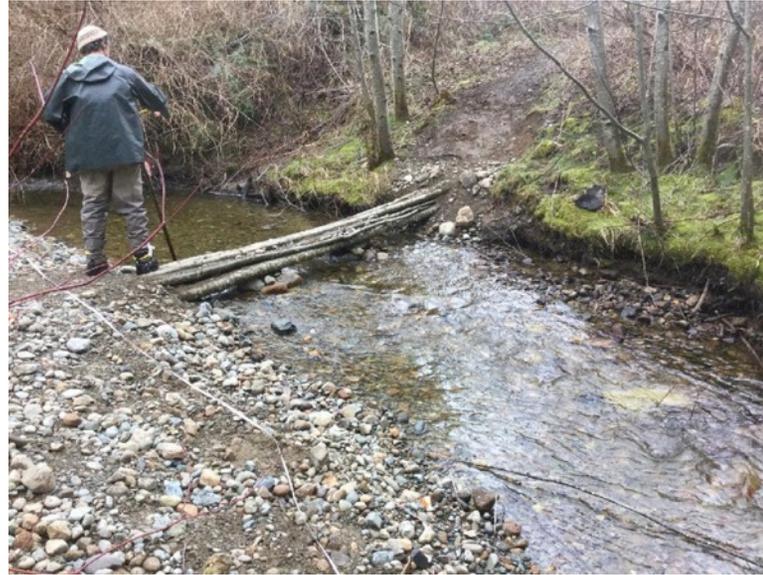
2.) Reach 4a at mountain bike crossing

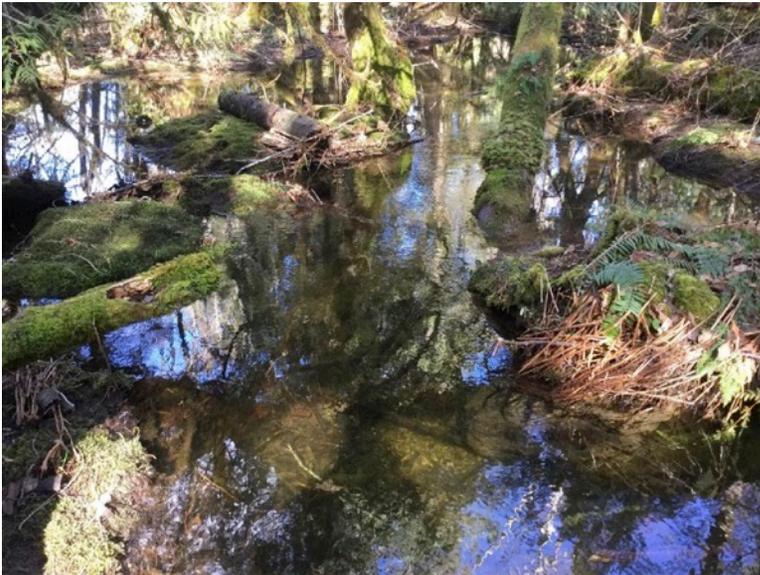
3.) Reach 4b typical disturbed channel

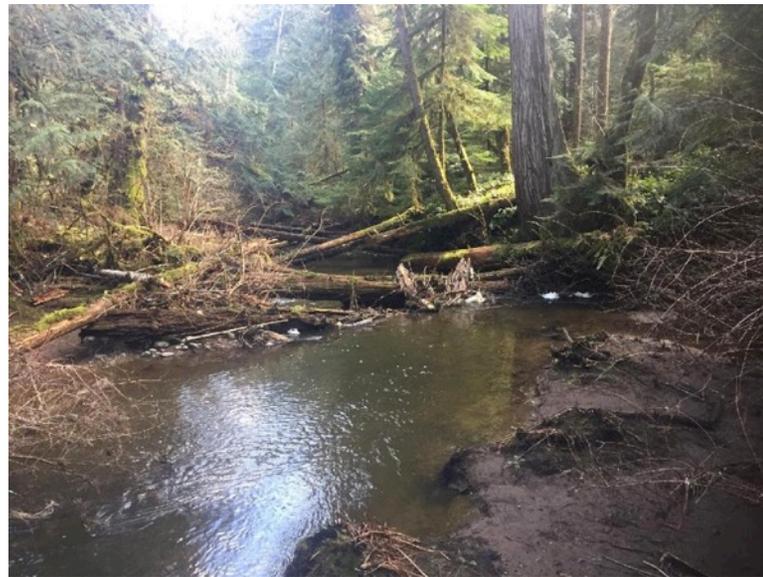
4.) There are some good cover locations (LW)
