**Shelly Creek Stream Assessment
And Fish Habitat Survey
(2014 and 2015)
Report**

Prepared by Peter Law, Faye Smith and Barb Riordan for

October 2016

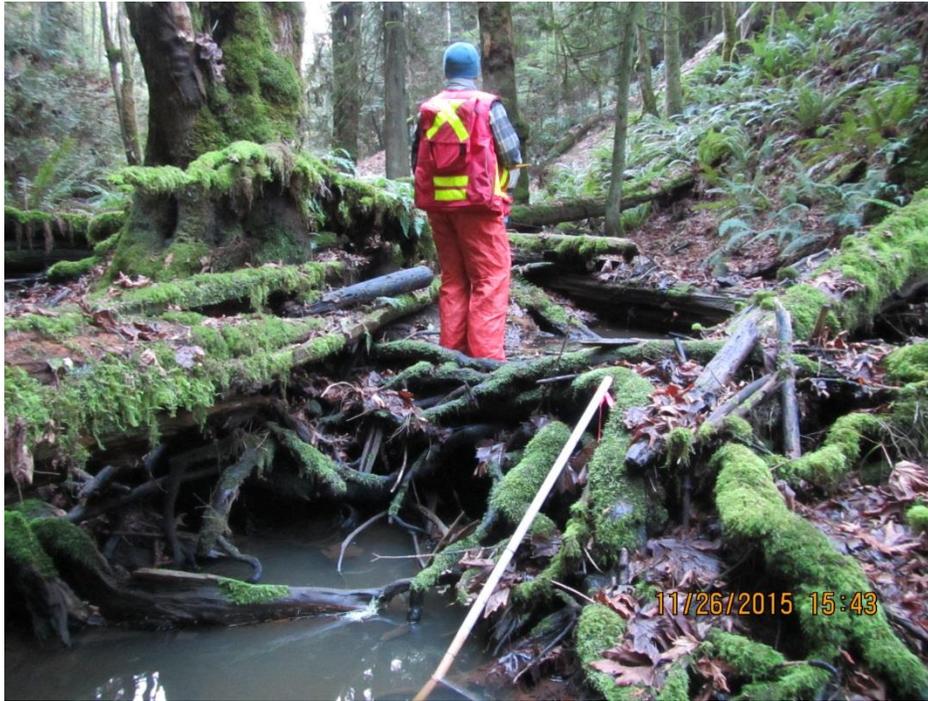
The stream channel in reach # 3 climbs to a five percent (+/-) gradient, resulting in a cascade pool type of stream channel with large woody debris jams (Table 4). This reach is confined to a deep forested gully which confines the channel. Several (bankful width) woody debris jams have created obstructions in the channel, where sediment accumulates above the jam and erodes a deep pool into the hardpan clay downstream during high winter flows (Fig. 4).

Figure 4. Example of Large Woody Debris Obstruction in Reach #3

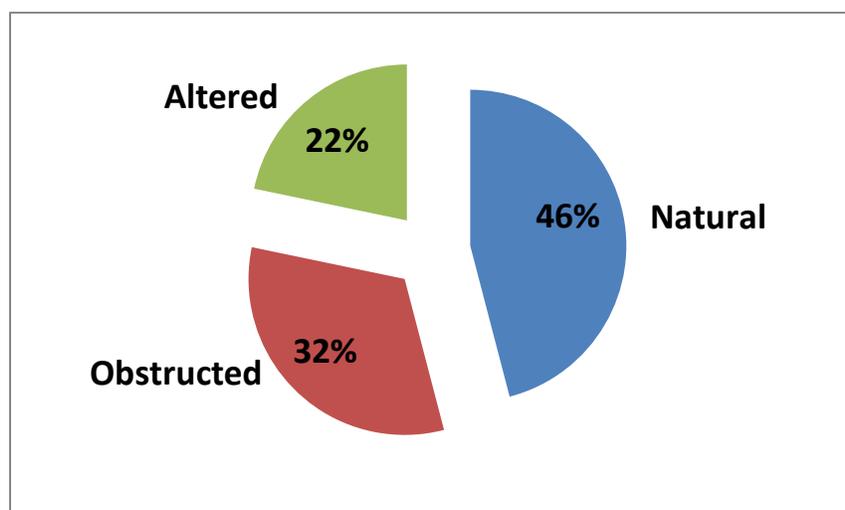
Within the reach, there were sixteen (bankful) debris obstructions with accumulated woody debris that accumulate in jams covering thirty two percent of the reach's length (Fig. 5). Three road crossings in this reach (including Hwy. 19) have culverted (altered) twenty two percent of the channel's length.

Figure 5. Channel Conditions in Reach #3 as Shown as a Percent of Length

The channel conditions appear to be a unstable, with forty percent of the reach aggrading (eroding) and the remainder being subjected to deposition of sediments during peak winter flows. This reach is devoid of surface water from May to early October every year.

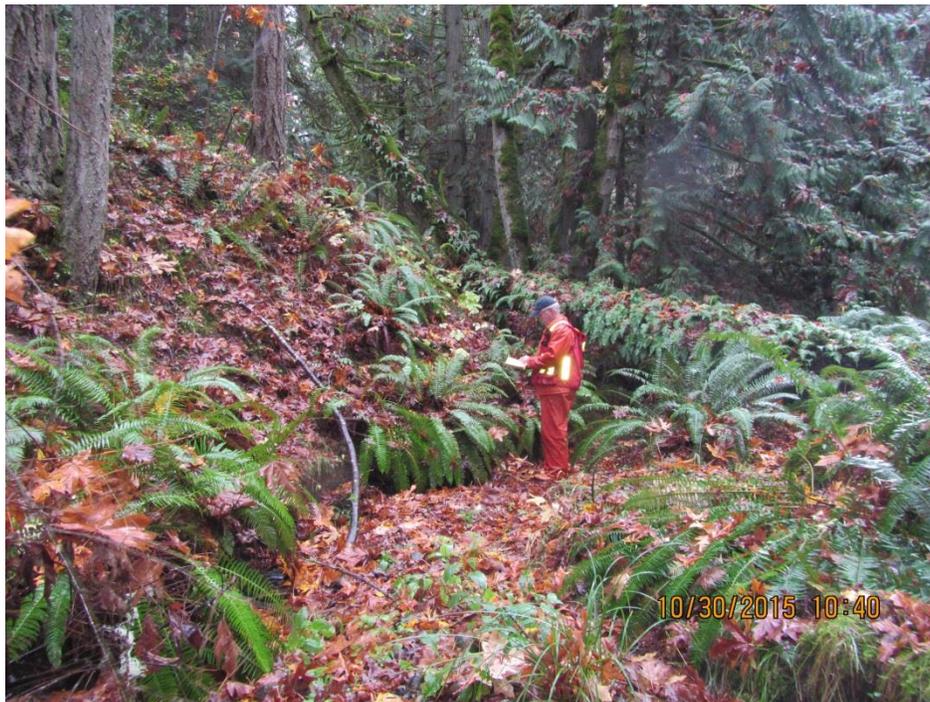
Riparian conditions through much of the reach are excellent, with maturing second growth conifer forest conditions providing stable riparian conditions (Fig. 6). Landuse is primarily forestry (Crown owned). Two hobby farms in the upper portion of the reach have resulted in enroachment of a building and (private) bridge impacting the channel.

Figure 6. Conifer Forests Dominate Riparian in Reach #3

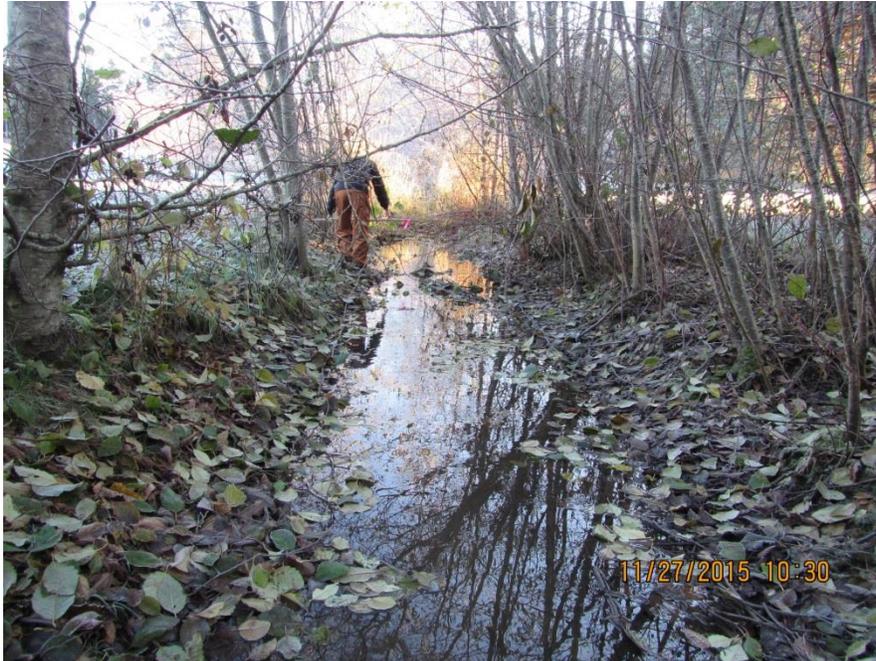
The riparian conditions of each assessment site assessed depended on the landuse. Where the stream channel crossed through a hobby farm's open pasture, the riparian conditions were limited to a two meter fringe of alder and shrub (Fig. 7).

Figure 7. Riparian Conditions of Shrubs Common to Reach #4
