Englishman River Claybank Stabilization Geomorphic Impact Assessment

Northwest Hydraulic Consultants Ltd.

October 4, 2023

Final Report, Rev. 1

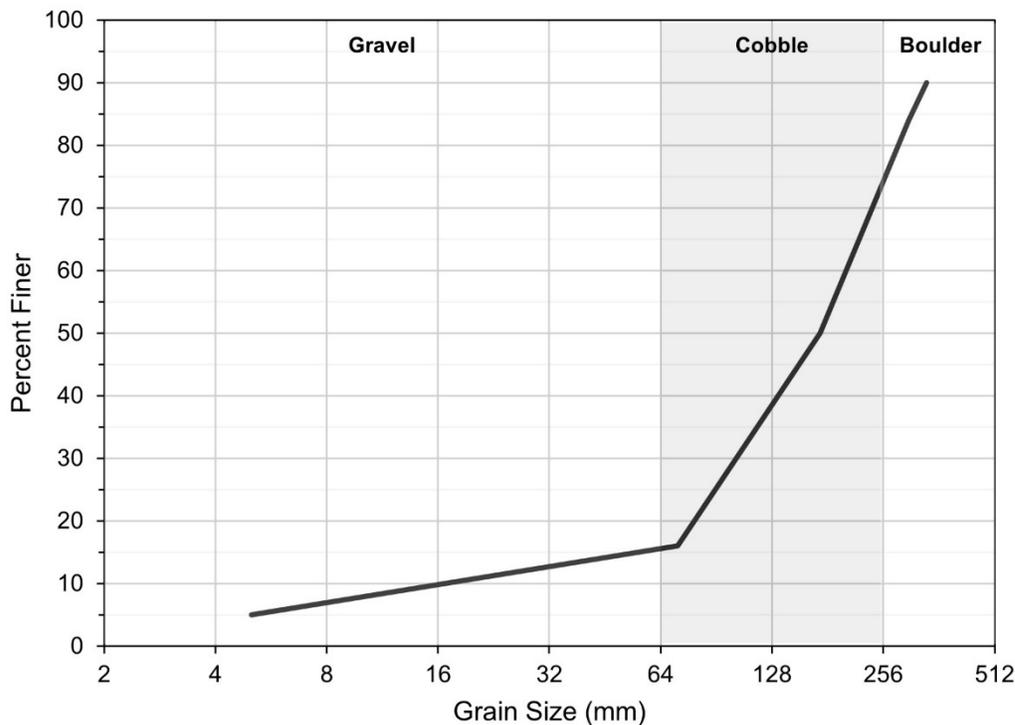
Across from the claybank, a coarse cobble-boulder bar has formed (Photo 3.3). A Wolman count collected at this location shows that the median size of surficial bed material (D_{50}) is 173 mm (cobble) and that the coarse fraction of the bed, as represented by the D_{84} , is 300 mm (boulder). The coarse sediment imparts a degree of stability to the bed, as these particles are likely only mobilized during extreme flood events. The increased resistance to flow provided by this bar may be deflecting higher velocity flows towards the claybank, contributing to the observed bank erosion.

Figure 3.1 Wolman count collected at the head of the cobble bar across from the upstream claybank (RK 8.6).

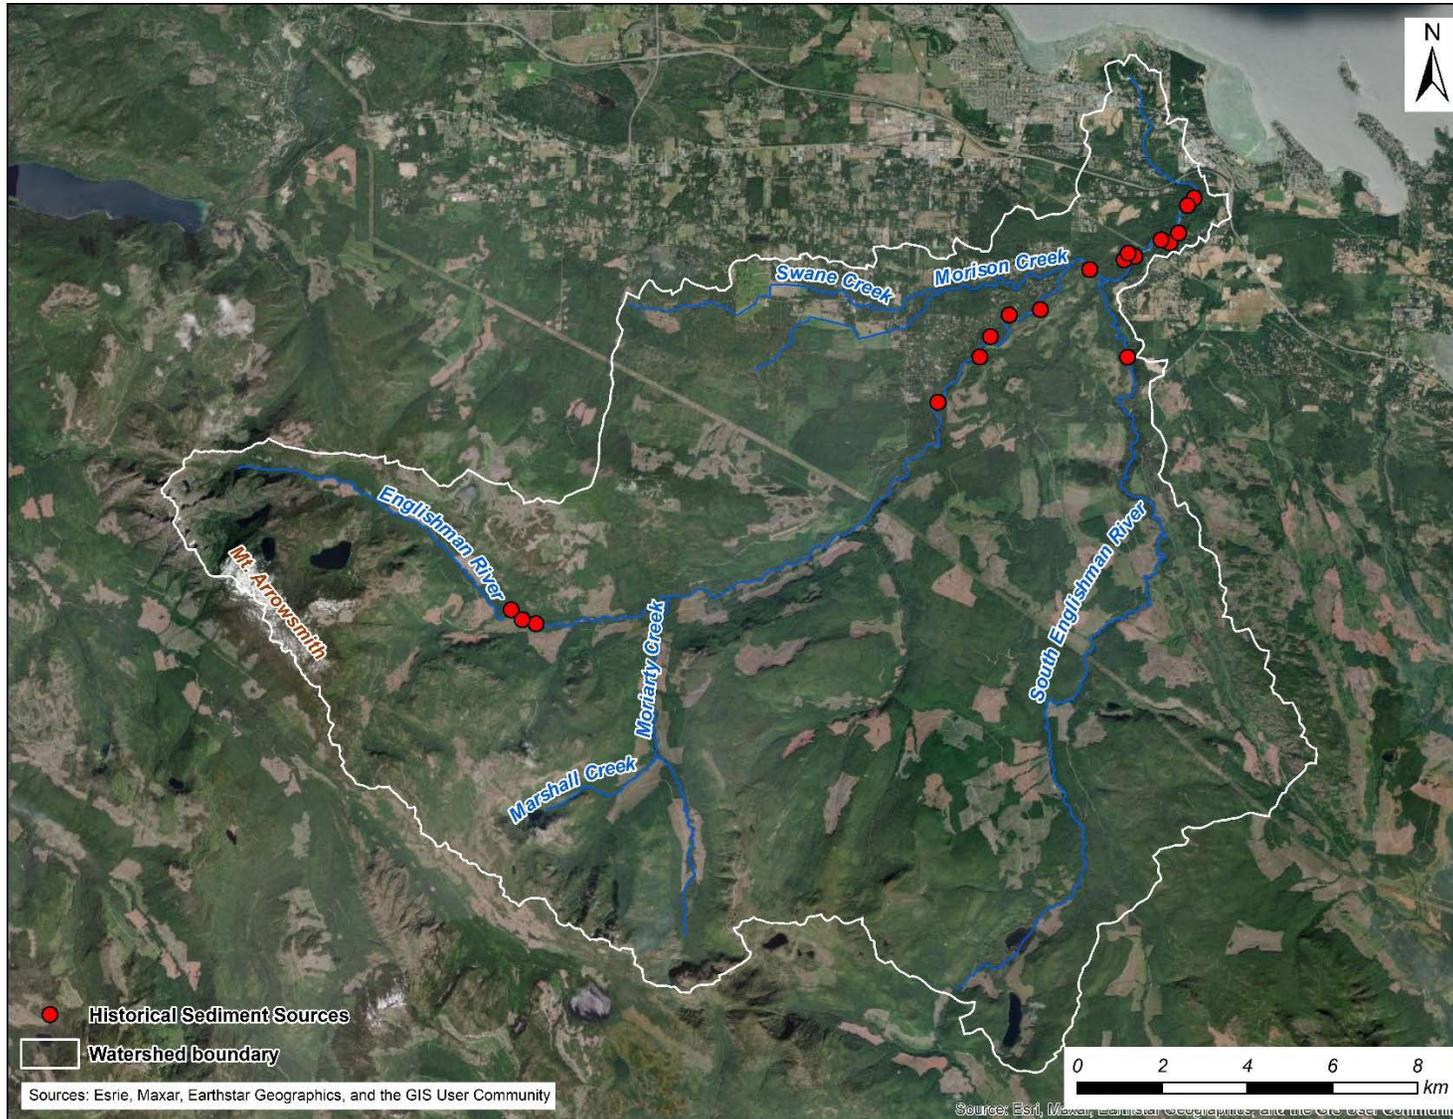
Figure 3.3 Historical sediment sources in the Englishman River watershed identified from air photos and satellite imagery.

However, the most abundant sediment sources in the watershed have historically occurred within the channel reach extending from the confluence with the South Englishman River through to Allsbrook Canyon (Top Bridge). This reach encompasses both claybank study sites as the river exits confinement and flows onto a 1 km wide floodplain. The reduced confinement and channel gradient through this reach allows the river to migrate more freely across its floodplain and deposit sediment supplied from upstream in the watershed. Here, the river is prone to periods of rapid bank erosion and lateral instability, with major cutoffs of high-amplitude meander bends. From 1949 to 1968, there appears to have been a high sediment load delivered to this reach, possibly related to logging activities, and as a result there was substantial channel straightening and steepening (Gaboury, 2005). In recent years, the river may be moving towards a more sinuous channel planform through this reach, in main part due to the rapid bank erosion at the downstream claybank (RK 6.3). From 2019 to 2021, the channel bank retreated by 40 m at this location (Figure 3.4), which has caused the river to impinge upon the glacial till unit forming the valley wall. This period of high bank erosion coincides with a period of high peak flows on the river (Figure 2.4a).

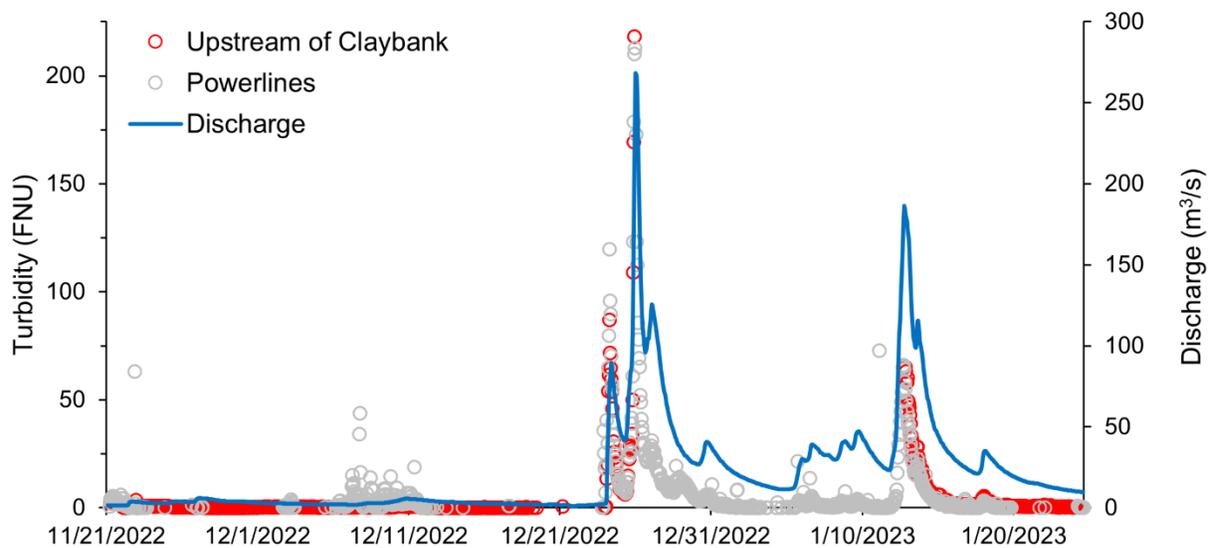
Figure 3.7 Turbidity and discharge hydrographs from November 21, 2022 to January 24, 2023 . Turbidity data provided by BCCF; preliminary discharge data downloaded from WSC website for gauge OHB002 (at the Hwy 19a bridge). The results from turbidity monitoring at the claybank (RK 8.6) show very little difference in turbidity between the two stations during the observed high flow events (Figure 3.7). This is interpreted to mean that during these events, sediment input from the claybank (and any other part of the river channel between the two sensors) was negligible compared to the upstream sediment supply. The greatest difference in turbidity between sensors occurred in early to mid-December, where the powerlines sensor exhibits a spike in turbidity absent from the upstream sensor (Figure 3.7). During this time, the river was at winter base flow conditions, so it is unlikely that streamflow velocities were high enough to cause significant erosion. The spike in turbidity may be related to slope failures at the claybank, though this cannot be confirmed.

The results from this analysis provide supporting evidence that the claybank is unlikely to be a significant sediment source in the context of the basin-scale sediment load, at least for the observed flow conditions. However, due to the short monitoring period, which encompassed just three high-flow events, these results should be interpreted cautiously. Erosion of the claybank can occur episodically, such that its relative contribution to the basin sediment yield will be highly variable from one flood to another. More extensive monitoring over a longer-time period would be required to better characterize the relative magnitude and frequency of sediment input at this site.

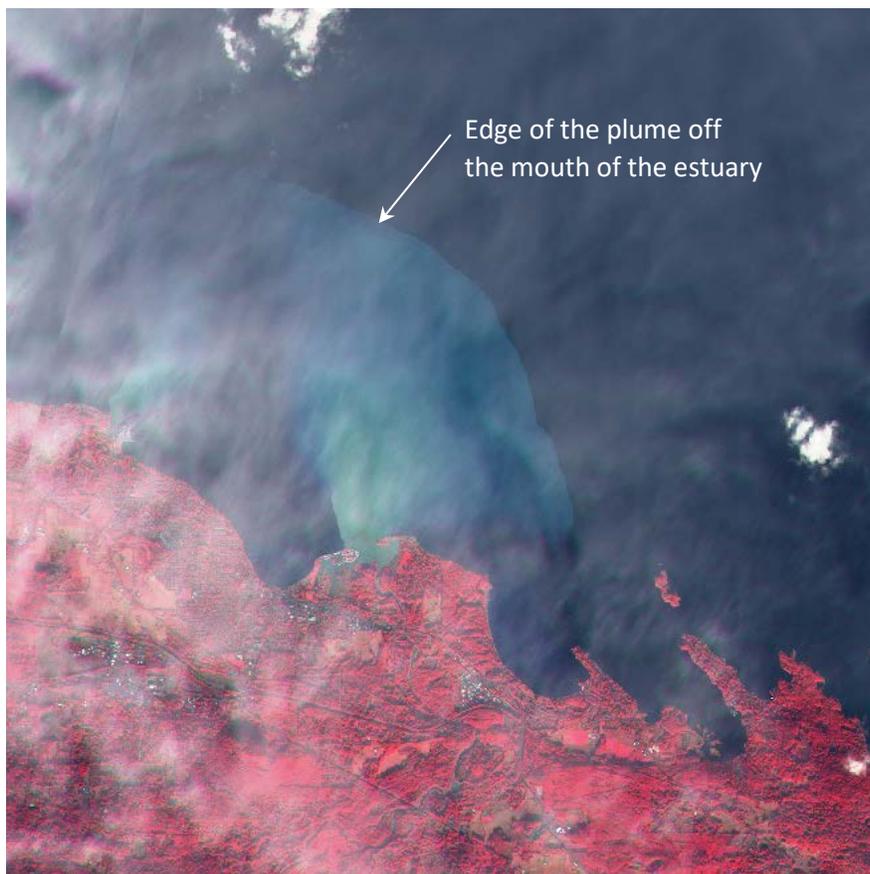
(267 m³/s), the sediment plume at the estuary extended several kilometres into the Strait of Georgia (Figure 3.8). We can infer from this that much of the fine wash load sediment (clay and silt) that is supplied from the upstream watershed, including the claybanks, is flushed through to the ocean during peak flood events capable of mobilizing the highest volume of sediment. Therefore, it seems unlikely that stabilizing the claybanks would have a meaningful impact on accretion rates in the estuary because much of the sediment sourced from the claybanks is wash load and does not appear to get deposited in the estuary.

Figure 3.8 Near infrared (NIR) Sentinel 2 satellite image of the Englishman River estuary from December 26, 2022.
