NHC Ref. No. 03000133

**MID VANCOUVER ISLAND HABITAT ENHANCEMENT SOCIETY**PO Box 935  
Parksville, BC  
V9P 2G9**Attention: Ms. Faye Smith**  
Project Coordinator**Via email:** [fsmith@telus.net](mailto:fsmith@telus.net)**Re: Shelly Creek Geomorphic Overview and Conceptual Level Habitat Enhancement Program Development**

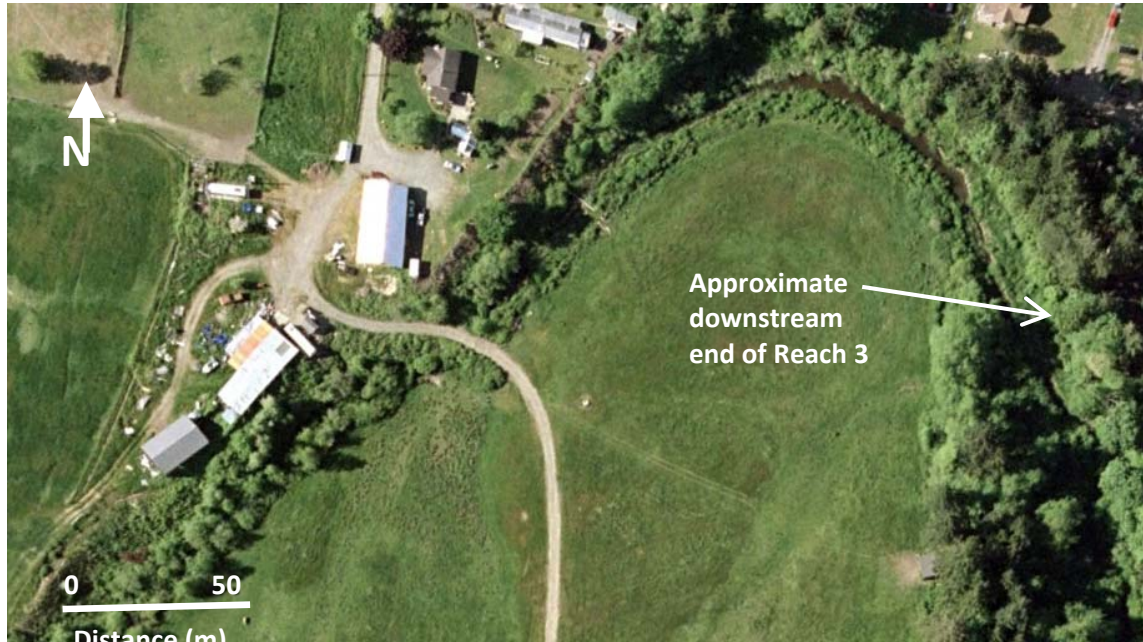
Figure 2. Google Earth™ image of portion of Reach 3 (21 May, 2007)

The downstream end of Reach 3 was defined based on differences in the active channel width and condition of the riparian zone (**Figure 2**). Reach 3 is about 400 m long with an active channel width that ranges between 7 to 10 m. Riparian habitat along the right channel edge is relatively sparse and the left bank is confined by a steep terrace. A culvert drains into the reach about 150 m upstream of the reach break and conveys storm drainage from Stanford Avenue.
