Restoration Plan:

Detailed Salmon Habitat and Riparian Overview with Level II Prescriptions

Center Creek Sub-Basin

Englishman River Watershed

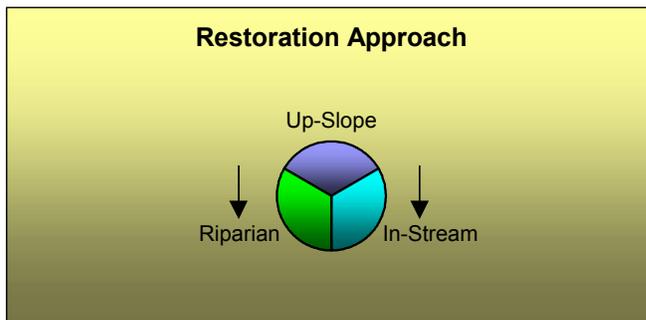
Figure 3. Restoration Approach

For restoration of impacted coastal streams, a top-down approach is recommended (Figure 3). Without addressing sediment sources (and especially upslope liabilities), in-stream restoration efforts can be ineffective²⁵. The ultimate goal for the up-slope restoration programs is to address unstable logging roads and/or sediment sources (through deactivation or upgrade) before any slides occur or have (or are estimated to potentially have) adverse impacts on aquatic resources. Eliminating chronic or severe pulse sediment sources is also of important consideration. Priority of up-slope deactivation (or upgrade) is determined by where it would be most beneficial in preventing or reducing excessive (above natural sediment budget levels) sediment influx.

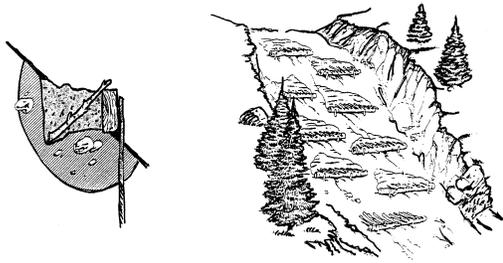
Figure 4. Modified Brush Layer (MBL).

Dormant willow cuttings are used to build living, self-maintaining, retaining walls on landslides. Willow is used because the cuttings grow roots where exposed to soil, and shoots where exposed to air

Grass establishes well on areas of a slide that are relatively stable. Zones of instability are identified the following year by observation of areas of poor grass establishment. Following the deactivation of the roads there is a focus on restoring the unstable portions of the landslides. To stabilize and revegetate the slides an approach called soil bioengineering is utilized (Figures 4, 5, 6). Basically this is the use of live willow cuttings to construct living, self-maintaining, retaining walls.

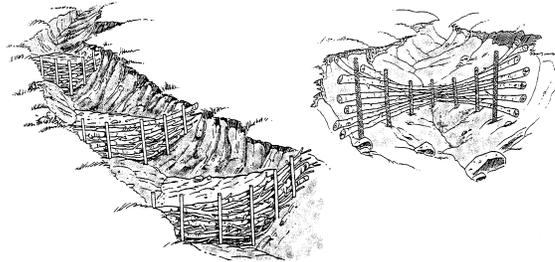
Figure 5. Live Gully Breaks (LGB).

These bioengineering structures are used to reduce the energy of incised areas of a landslide.

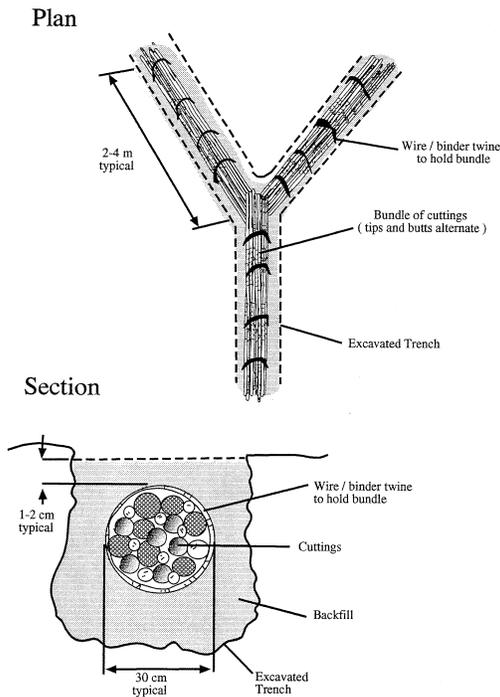
Figure 6. Live Pole Drain (LPD)

These bioengineering structures are used to create a living self-maintaining pipe in incised areas with relatively consistent water flow or seepage.

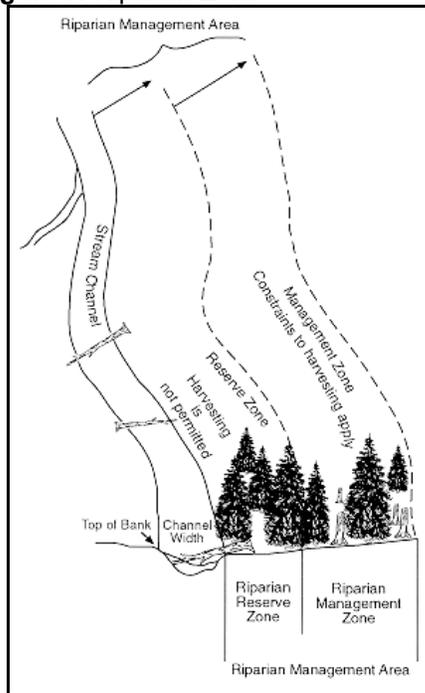
Figure 7. Riparian Zone

In the past, cut blocks were logged right to the stream banks, which virtually eliminated any chance of larger trees dying and falling into the stream (LWD recruitment). In many cases Alder, Maple, and brush have taken over the riparian areas of the streams and rivers. While Alder and Maple can supply good cover, when they die and fall in the stream they break down quickly (compared to conifers). Maple is superior to Alder as its root strength is substantially higher. Stream rehabilitation projects should have a strong focus on riparian restoration that focuses on developing uneven aged coniferous riparian zone with a mixture of deciduous.

Only when the high-risk up-slope areas have been addressed should the in-stream restoration work proceed. In-stream work is generally divided into two components: riparian (Figure 7) the vegetative buffer strip along a stream, and actual in-stream work. Generally, the wider the stream, the greater the riparian reserve that should be established for protection of the important terrestrial and aquatic habitats (Figure 8)²⁷.

The riparian reserve zone and riparian management is assumed (and recommended) in this report to follow (at minimum) the Forest Practices Code Guidelines for recommended riparian width (Figures 7 and 8). Within the area covered by this report, Center Creek falls within the S2 stream classification (>5m ≤ 20m bank full width) which requires a minimum of a 30m riparian reserve zone (RRZ), and an additional 20m management zone.

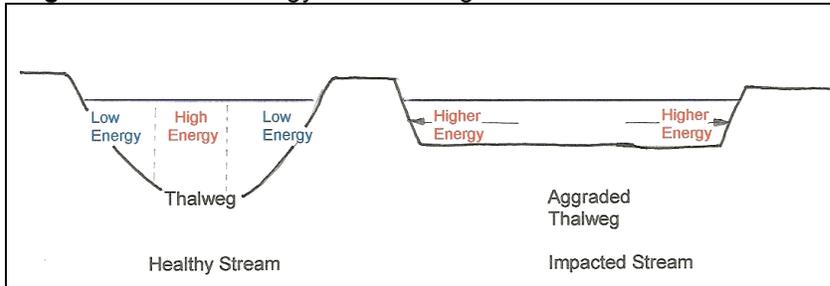
Figure 9. Stream Energy and Thalweg

As this energy erodes the banks (made even less stable with the lack of large conifer roots), the bedload problem is compounded.

An aggraded thalweg is the legacy of combined upslope and riparian impacts. This is visually apparent in the anadromous reaches of Center Creek. Restoration of upslope, roads and riparian zones attenuate the flood effects, cut off the sediment loads and strengthen stream banks. This leads to opportunities for recovery of instream LWD function.

A common result in high relief (steep) areas of some pre-1995 logging practices, is that debris torrents have swept away many of the natural LWD structures rendering the stream system relatively featureless (low pool, riffle, and glide frequency). The bedload fills in the pools and thalweg (the deepest section of a stream) causing in the energy of the stream to be re-distributed towards the stream banks (Figure 9)²⁶.

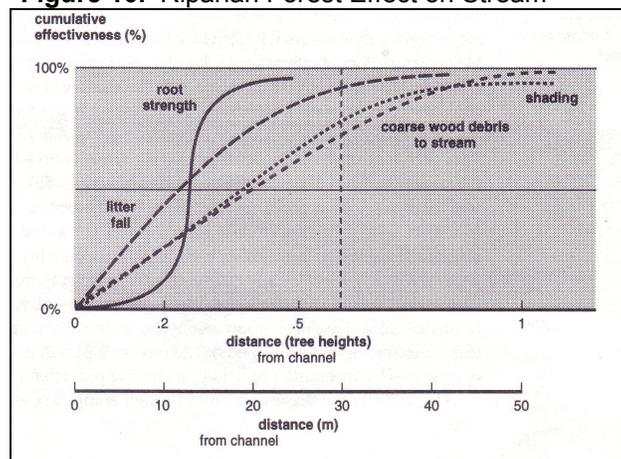
Figure 10. Riparian Forest Effect on Stream²⁸

Riparian restoration is necessary for ensuring a future source of LWD recruitment, as well as ensuring bank integrity, litter fall input, and shading (Figure 10). The riparian area is an important source of LWD²⁹ and is also has very high value for wildlife habitat. The zones with the highest mammal species diversity are found in the CWH and IDF zones.

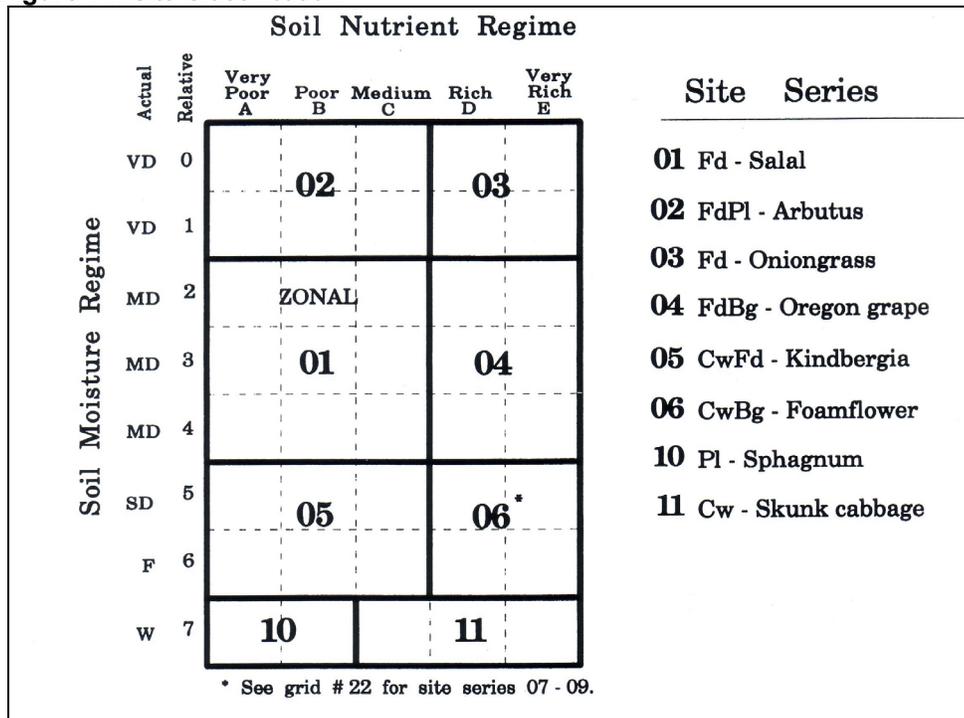
Figure 14. Site Classification⁴⁶

Specific site level classification is further delineated into a "Site Series" designation based upon soil moisture and nutrient regime (Figure 14). Indicator plants are used, along with soil moisture and nutrient regime to help determine site series classification (Figure 15).

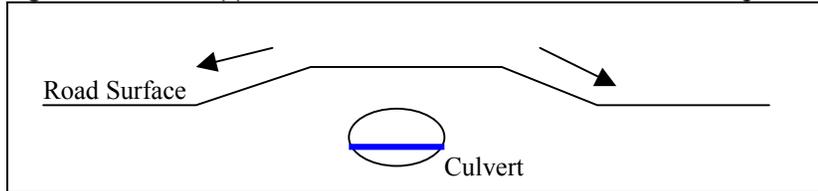
Figure 16. Road approach recommendation for stream crossings

- If ditch lines are maintained, make efforts to make the ditches as deep and as wide as possible to extend the required maintenance intervals as long as possible.
- Deactivation and seeding of lesser utilized roads to lower the road density
- Increase culvert frequency to maintain natural drainage patterns.
- Road approaches to bridges or culverts should slope away from water course (Figure 16)
- Avoid grading into ditch lines
- Install buffer logs on roads that cross watercourses to prevent accidental grading into stream.

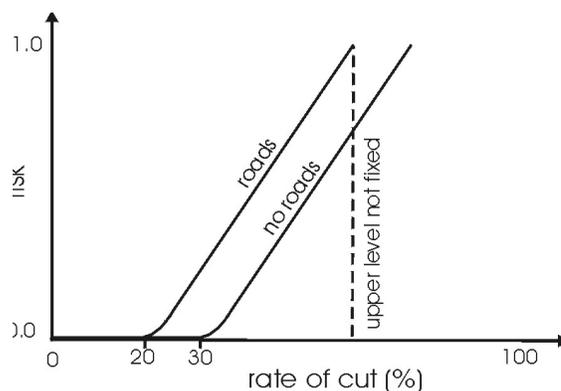
Figure 17. Risk to Stream Integrity⁵⁷

Depending on watershed characteristics, risk to stream integrity may increase significantly if greater than 20 percent ECA (Figure 17) of the watershed has been harvested. It is recommended that this component be monitored and carefully managed by the land owner/s.

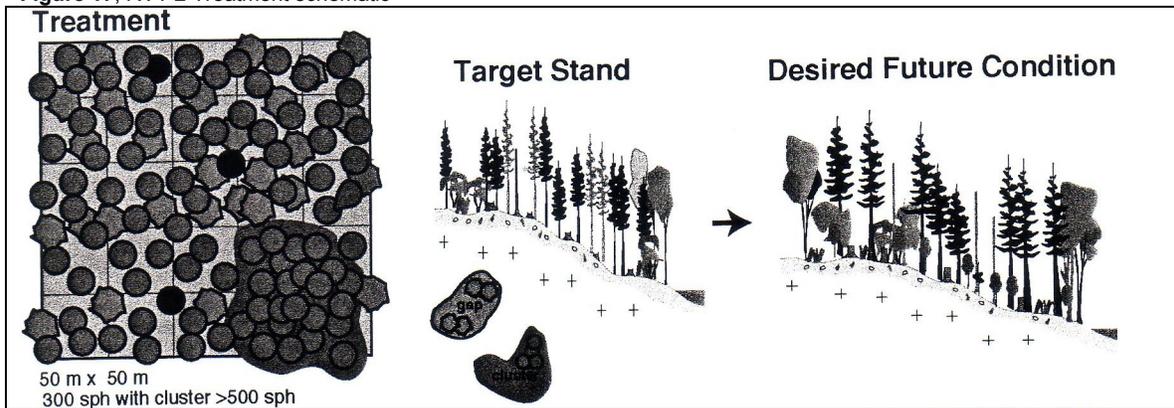
Figure 17, RVT 2 Treatment schematic⁶³

- (See Appendices 8, 9 and 10 for detailed treatment descriptions)
- Creation of standing dead trees – provide critical nesting habitat for birds that nest in cavities excavated from wood
- Creation of stressed trees – second growth stands are usually too healthy and supply little opportunity for insect colonization. Scarring or partially girdling will reduce the vigor of the tree.

- Thin out ½ to ¾ tree length patches to create openings around areas of poor understory density, and Thin out ½ to ¾ tree length patches to create openings around root rot centers. The openings should be roughly on 40 to 55m centers (Figure 17).
